RESERVE STUDY

Stone Ridge Condominium Homeowners Association, Inc.
11450 Ashland Circle
South Lyon, MI

Date of Inspection: August 16, 2021

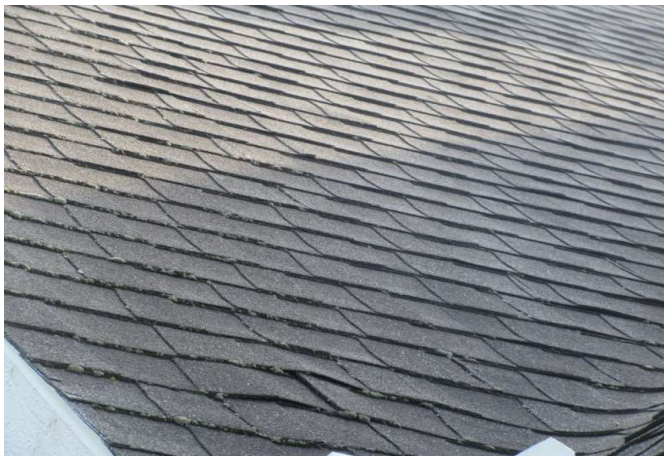
Organic growth on roof

View of minor shingle lift and organic growth

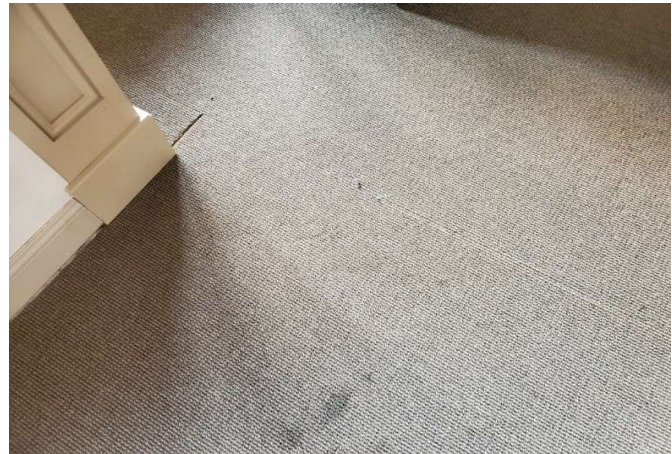
Stained carpet

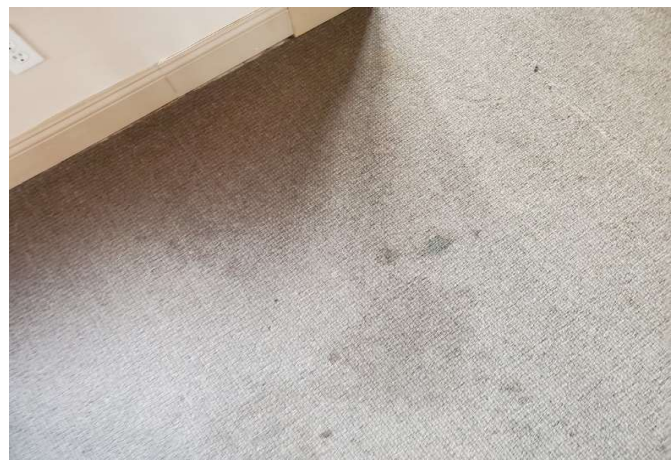
Stains on clubhouse carpet

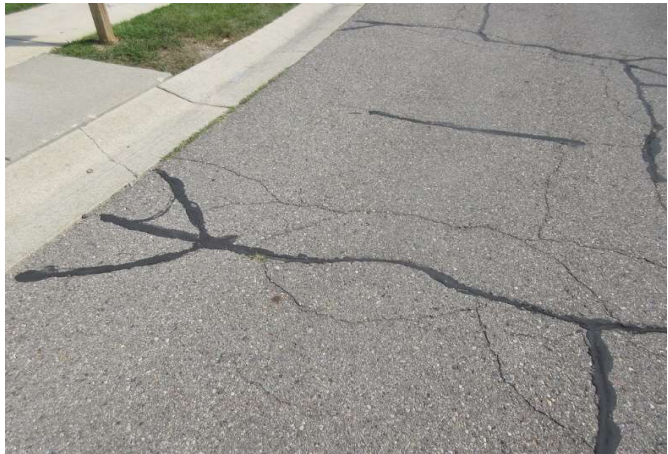
Crackle and repairs

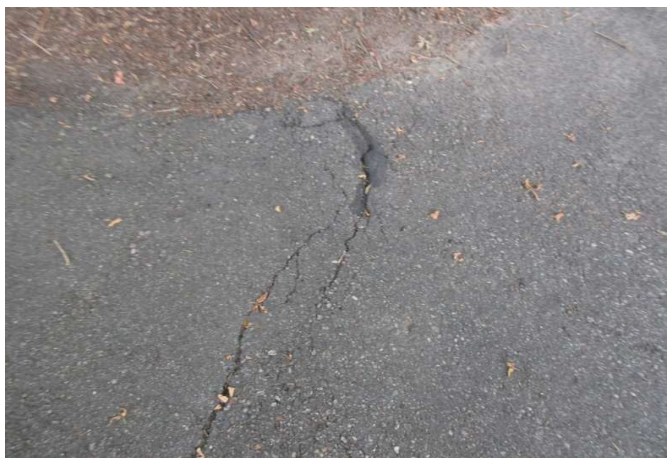
Surface crack

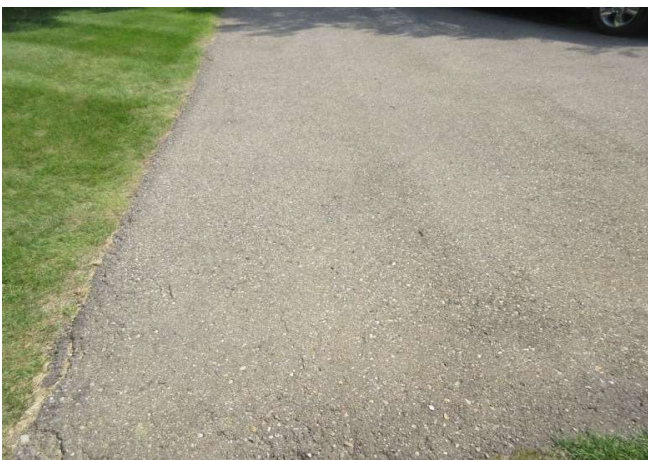
Aerial view showing cracking

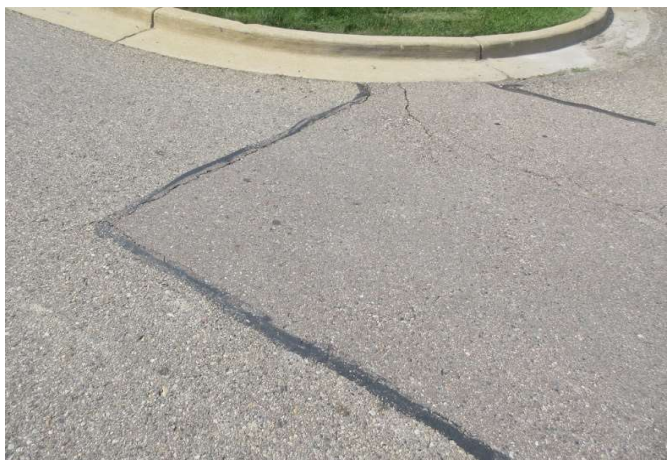
Patched pavement

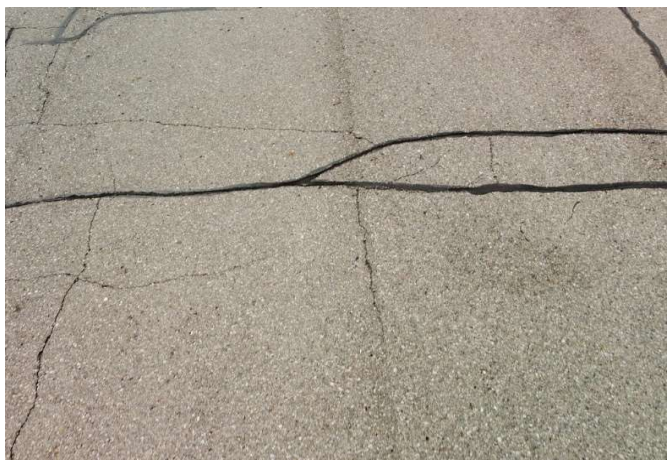
Cracks and crack repairs

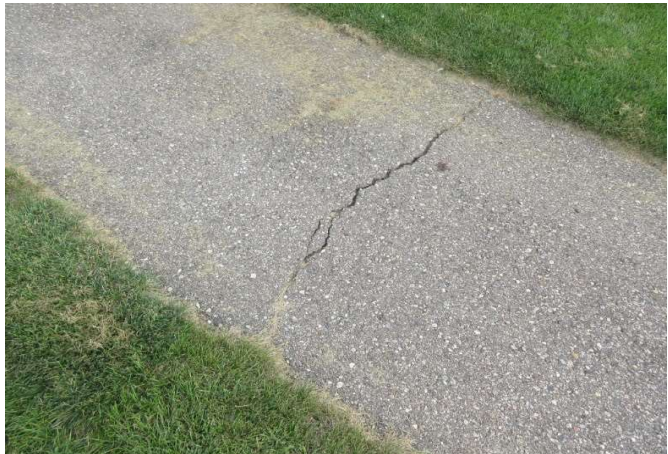
Crack in walk

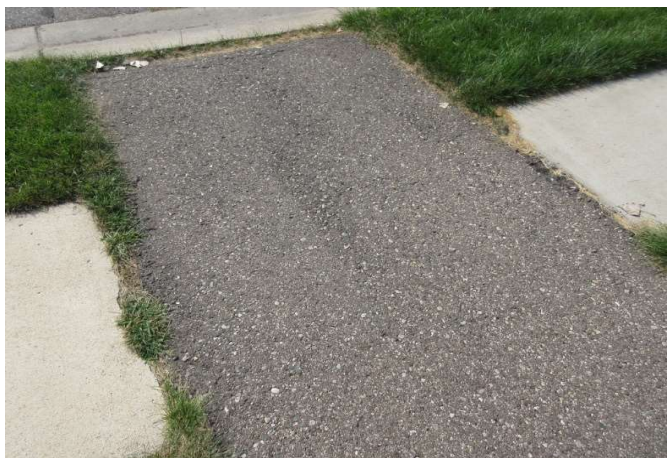
Settled walk at street

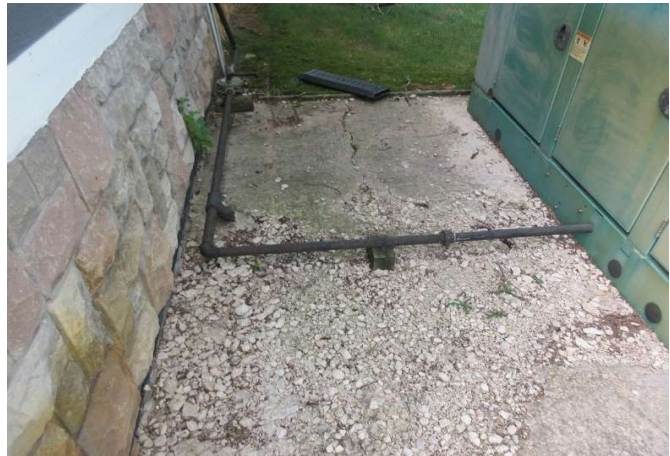
Deteriorated pad

Pad deterioration at generator

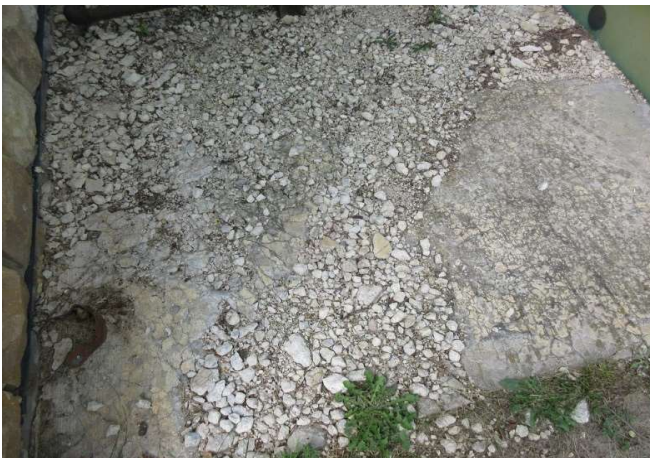
Deteriorated concrete

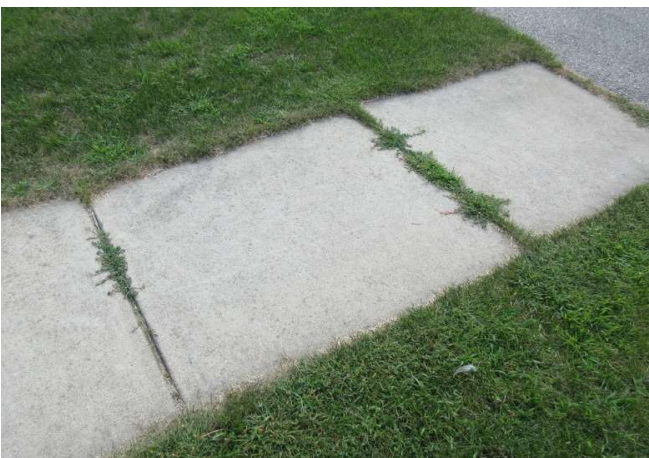
Cracks in walk

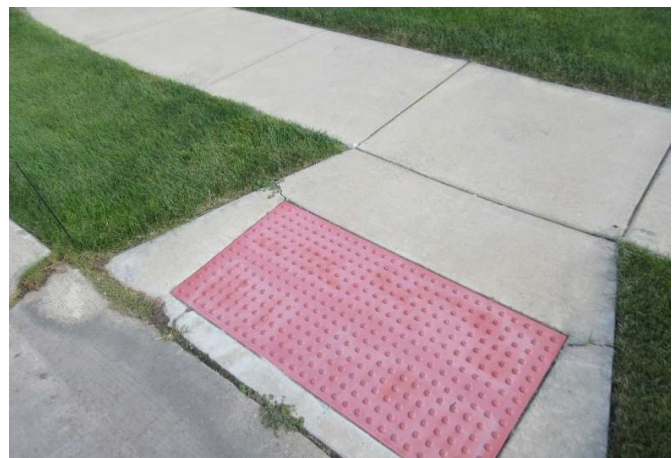
Weed growth in heaved walk

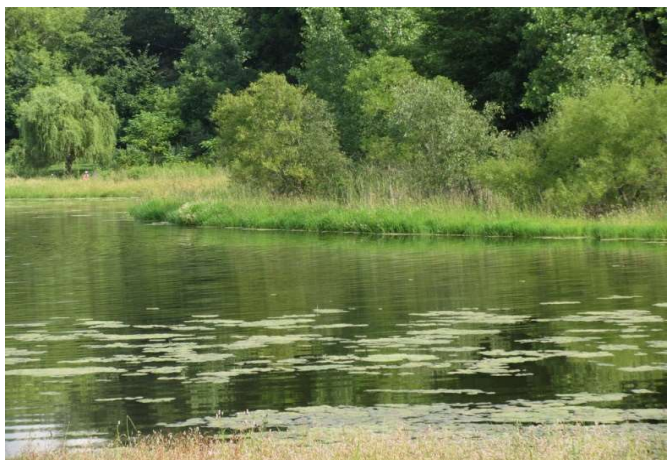
View of overgrown forebay in pond

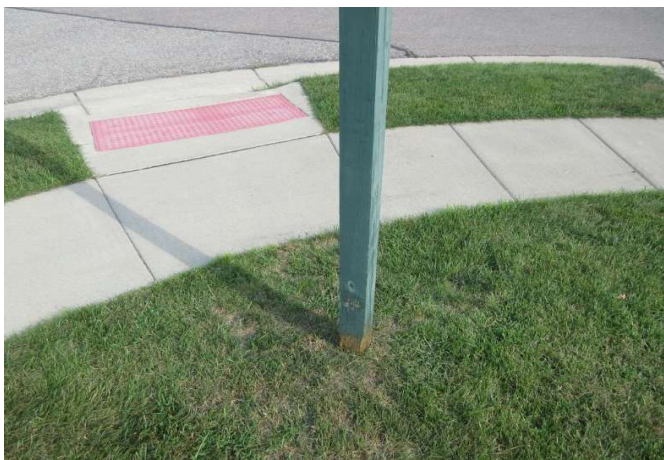
Deteriorating street signage

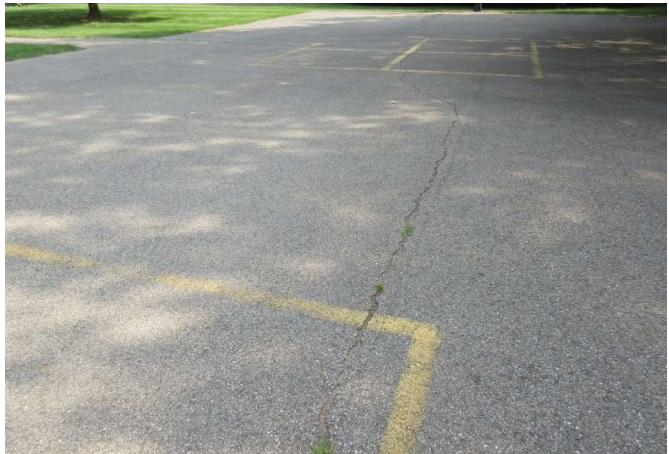
Crack in court

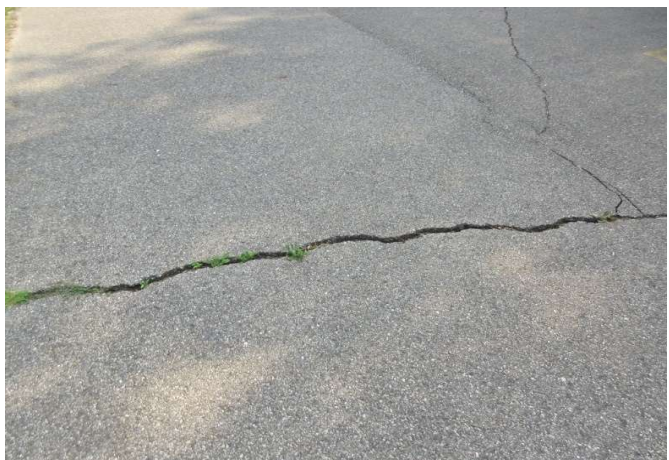
Cracked asphalt basketball court

Large crack in play surface
