RESERVE STUDY

Stone Ridge Condominium Homeowners Association, Inc.
11450 Ashland Circle
South Lyon, MI

Date of Inspection: August 16, 2021

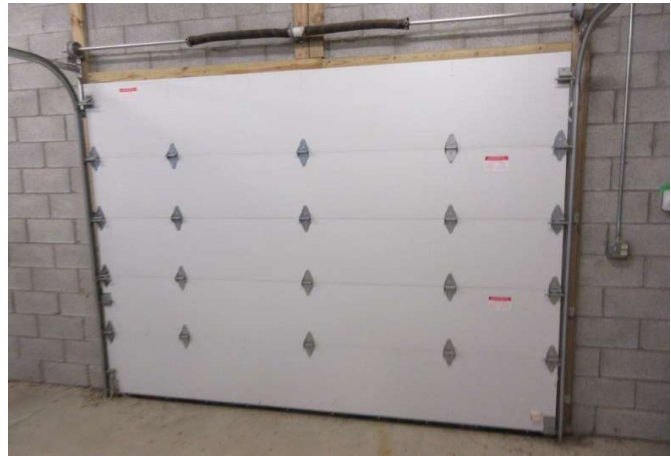
Interior of garage door

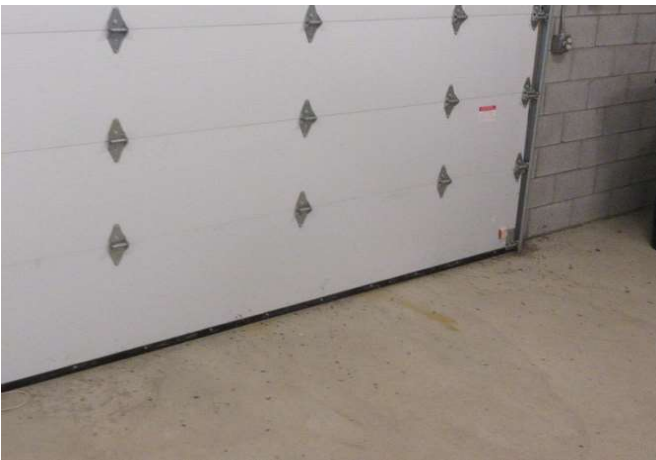
Interior side of panels

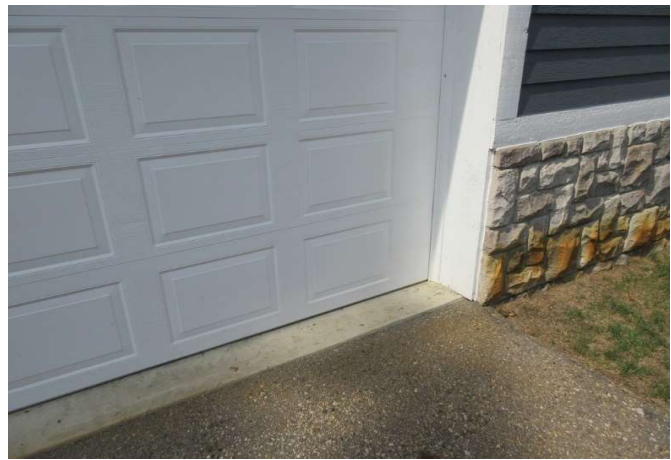
Typical exterior condition

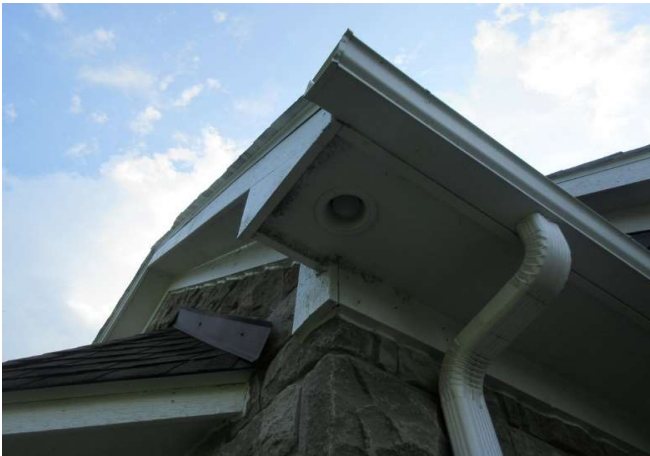
Gutter at soffit

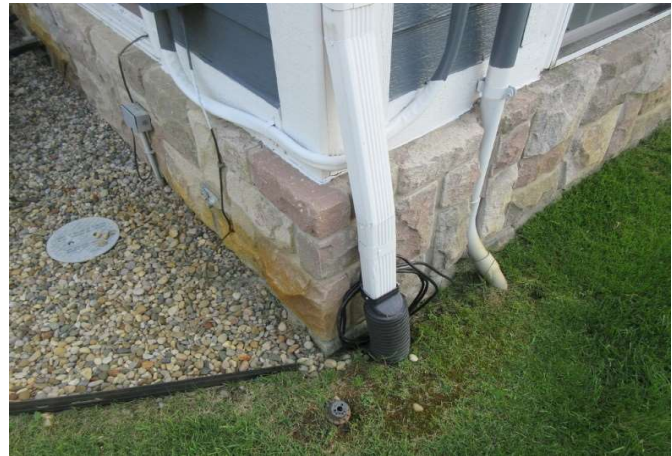
Downspout at grade

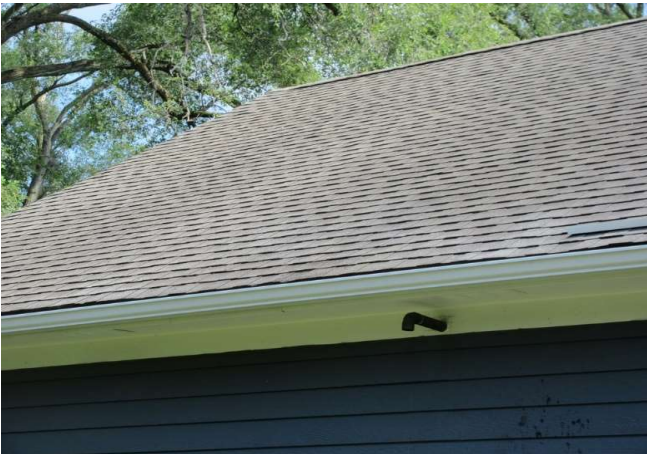
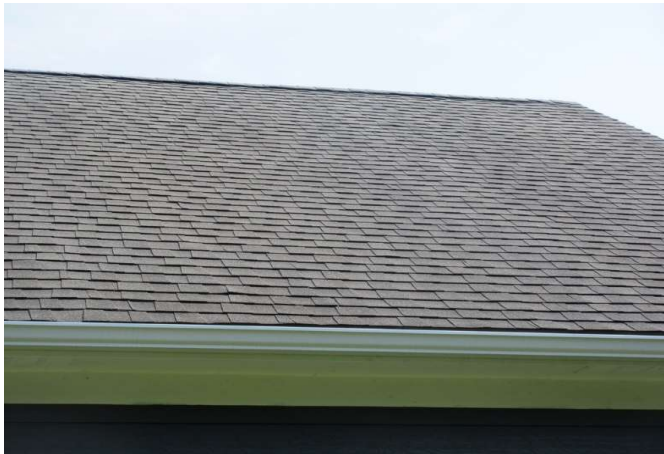
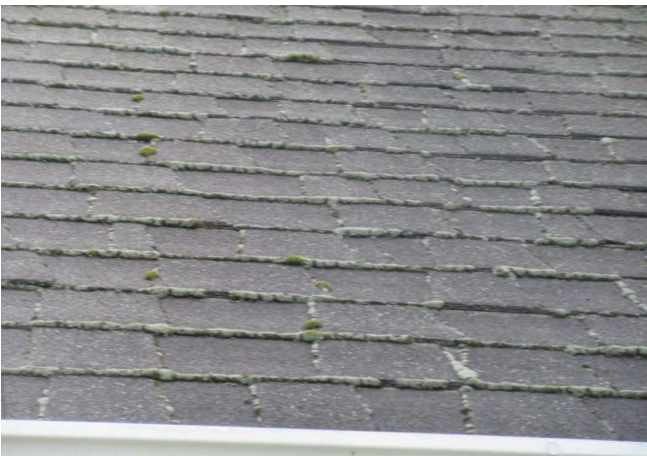
View of shingles

Roof at clubhouse

Organic growth on roof

Asphalt shingles are located at the clubhouse, wellhouse, and pumphouse roofs. The Board did not report any known active leaks at the roofs. Our visual inspection from the ground notes shingles in fair condition. We recommend the Association budget for replacement of the roofs by 2025 and again by 2045. The Association should fund inspections and repairs from the operating budget to maximize the remaining useful life of the roofs.

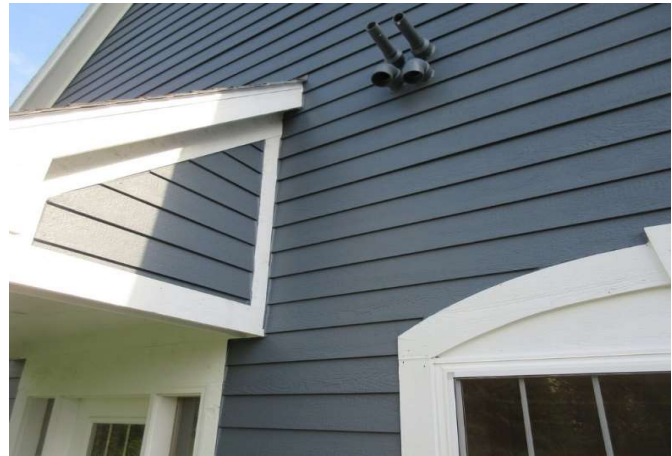
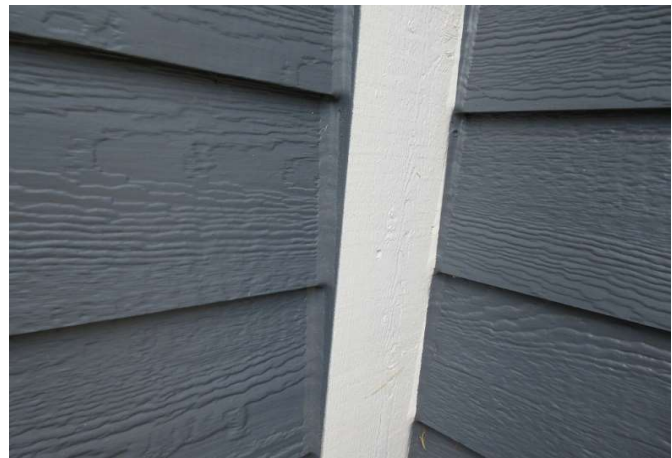
Typical siding

Siding at clubhouse

Siding surface

Detail of siding

The three common buildings (clubhouse, wellhouse, pumphouse) are clad in composite siding. The siding was recently painted (2020) and the condition is good. Composite siding has a typical useful life of 35 to 45 years. We recommend replacement by 2050. Please note that this component also includes the soffits and fascia at the common buildings.

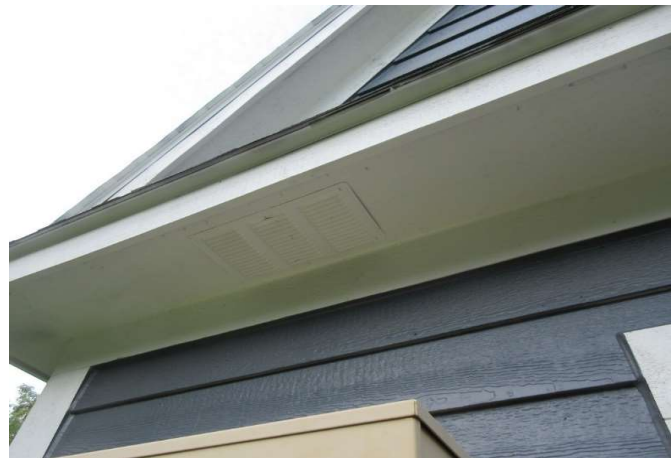
Wood soffit

Painted wood soffit at entry

Painted surface

Vented soffit panel and painted surfaces

The exterior of the clubhouse, wellhouse, and pumphouse are comprised of composite siding with wood soffits and fascia. The exteriors of the common buildings were painted in 2020. We have included future painting and partial replacement of wood fascia and soffit every 6 years starting in 2026. This will allow the upkeep of the building exteriors and replacement of any poor condition areas of wood throughout this study.

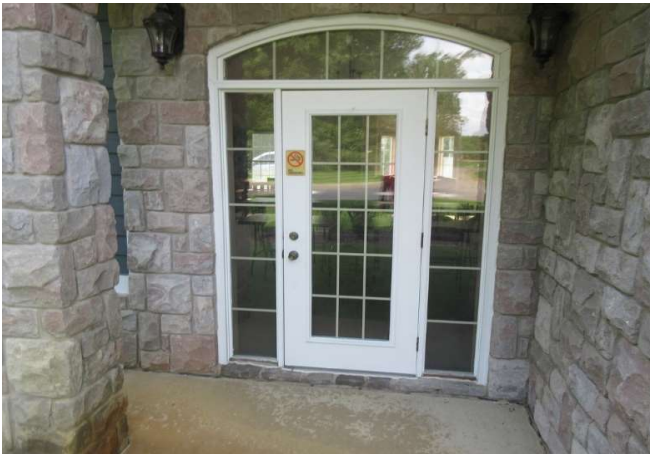
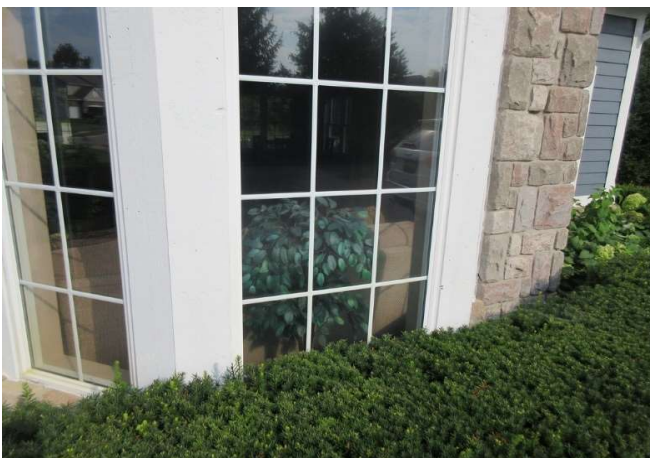
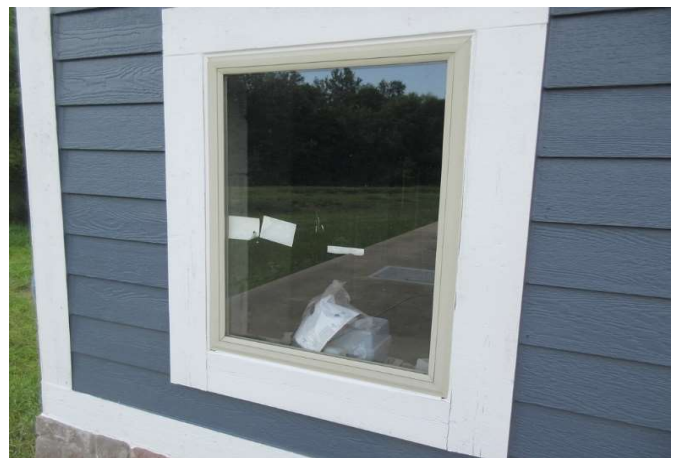
Typical clubhouse entry door

Window, typical

View of bay window

Window at pumphouse

This component includes the replacement of the windows and exterior entry doors at the clubhouse. Utility doors located at the wellhouse and pumphouse are considered an operating cost for replacement. We recommend that the Association reserve funds for replacement of the windows and entry doors by 2050, in coordination with siding replacement.

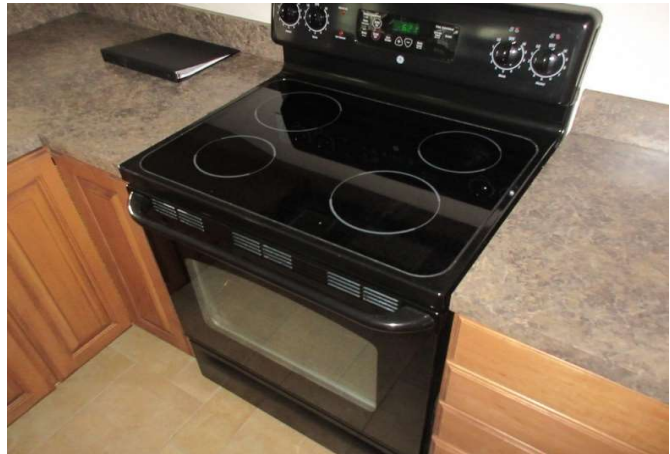
Refrigerator

Oven at kitchenette

View of dishwasher

Microwave above oven

The appliances at the clubhouse include a refrigerator, stove with cooktop, microwave, and dishwasher. These items date from the original construction of the clubhouse. We recommend replacement of the appliances by 2030.

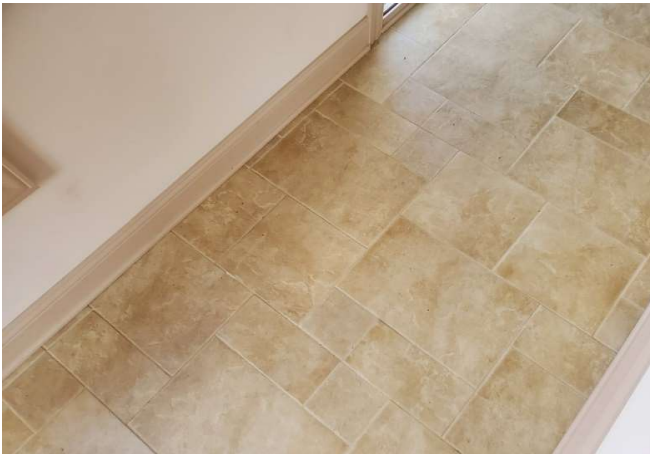
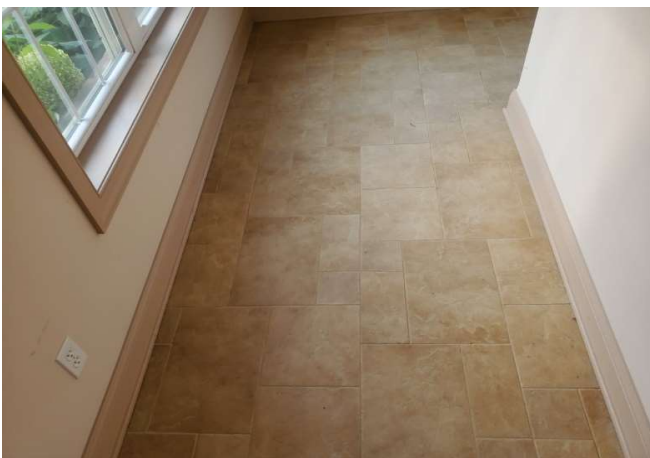
Tile in hallway

Restroom tile

Floor in clubhouse hallway

Typical condition

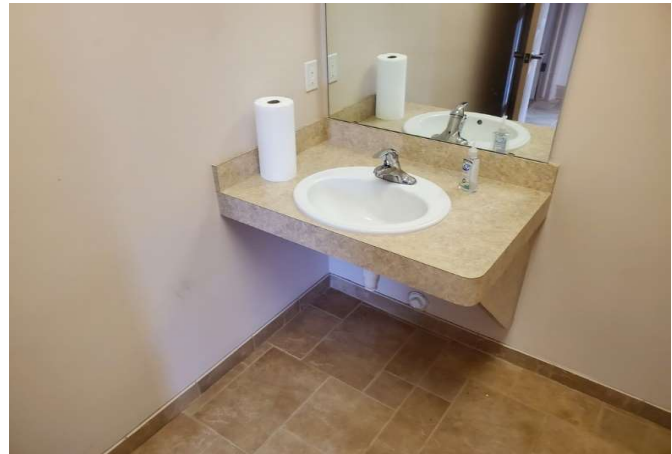
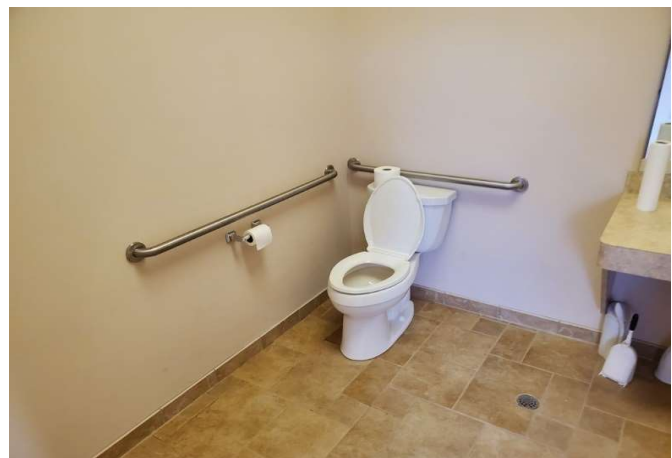
Restroom toilet area

Sink area, typical

Sink countertop

ADA accessible toilet area

Engineering Narrative
<p>Two rest rooms are located in the clubhouse. The finishes of the rest rooms include ceramic tile and paint, which have been included in separate components in this report. Renovations to the restrooms include replacement of fixtures including toilets, sinks, and accessories. The timing and cost of rest room renovation can vary significantly depending on the desires of the Board. At this time, we include an allowance to renovate the rest rooms by 2040.</p>

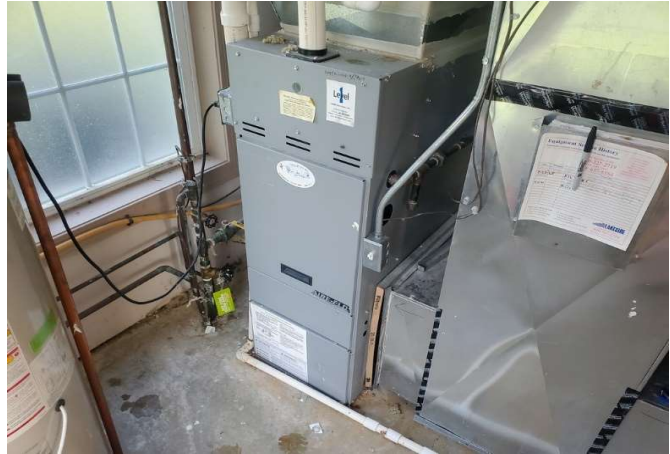
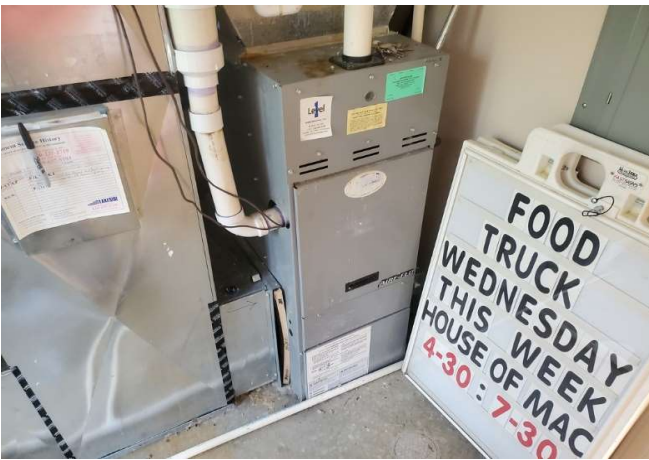
Typical AHU

AHU in mechanical room

View of furnace

Furnace

There are 2 air handling units located in the mechanical room at the clubhouse. These units appear in fair condition at an age of 17 years. We recommend that the association reserve funds for replacement by 2025, and again by 2045, in conjunction with replacement of the condensing units. The units are 100-MBH gas fired units.

Overall Current Condition:	Fair
Useful Life in South Lyon, MI	15 to 20 Years
Full or Partial Replacement:	Full

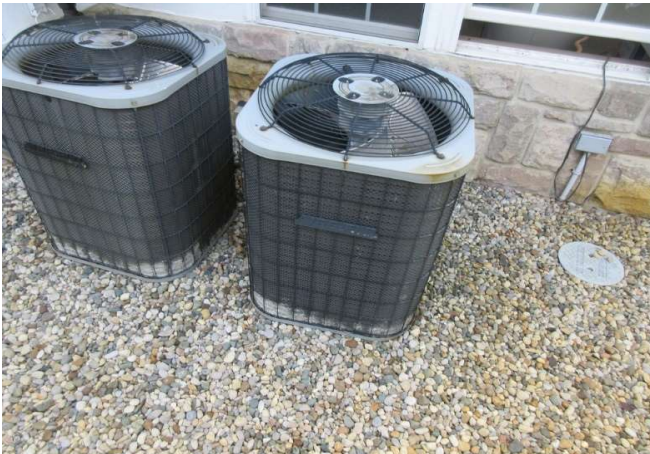
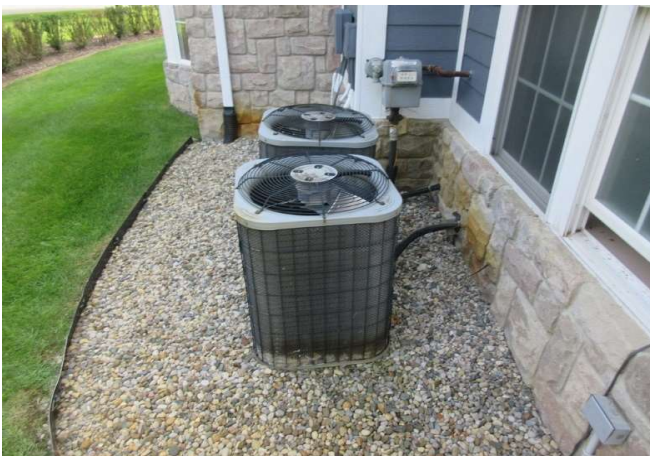
Condensing units at clubhouse

Typical condition

View of condensing unit

Typical unit

Two condensing units are located at the clubhouse. These condensing units date to the original construction of the clubhouse. Condition of these units appears fair. We recommend that the association replace the condensing units at the clubhouse at the same time as furnaces in 2025, and subsequently in 2045.

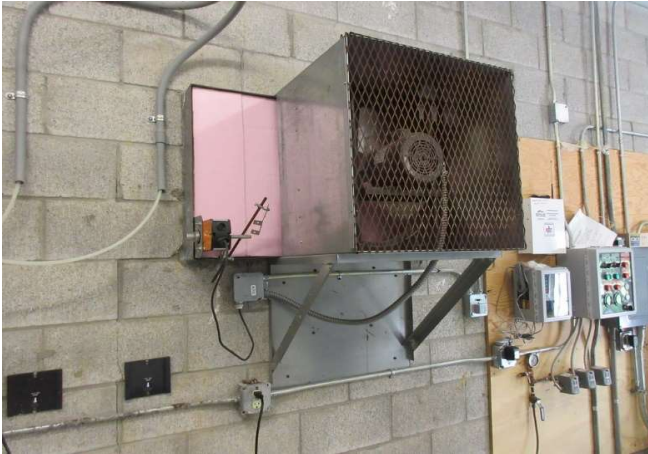
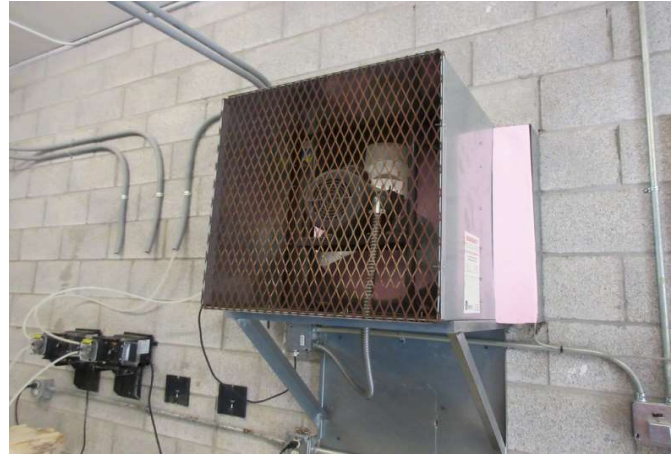
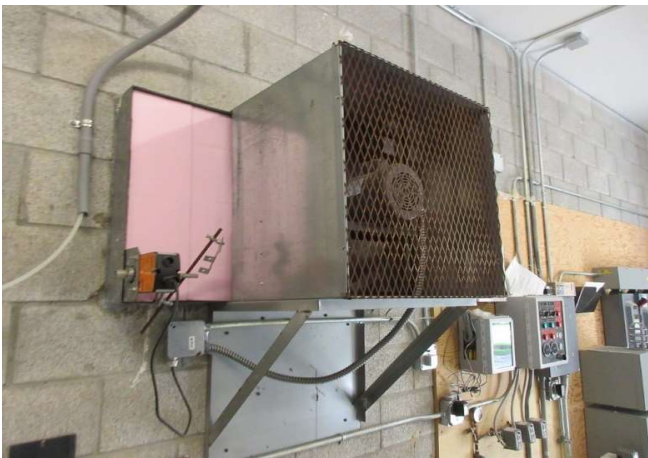
Fan in pumphouse

Exhaust fan at pumphouse

View of fan

A single exhaust fan is located at the pumphouse. This unit provides fresh air circulation for the interior of the pumphouse. The unit appears in good condition at an age of 17 years. Replacement of exhaust fans is recommended every 25 to 30 years. We have included funds for replacements of the fan by 2035.

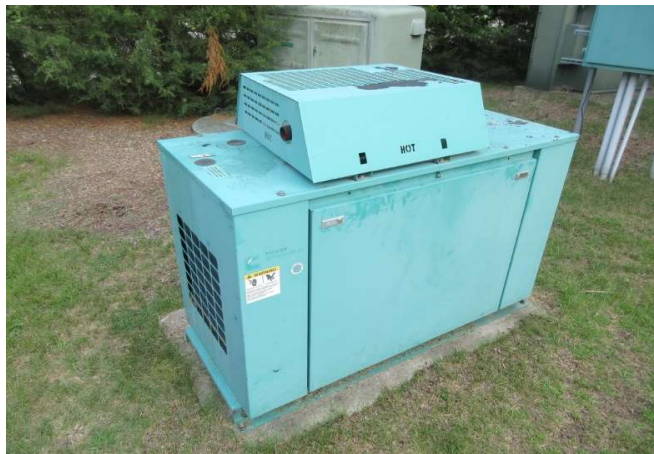
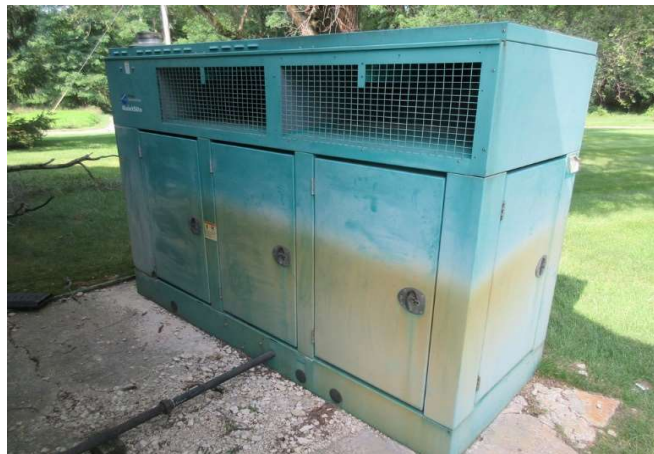
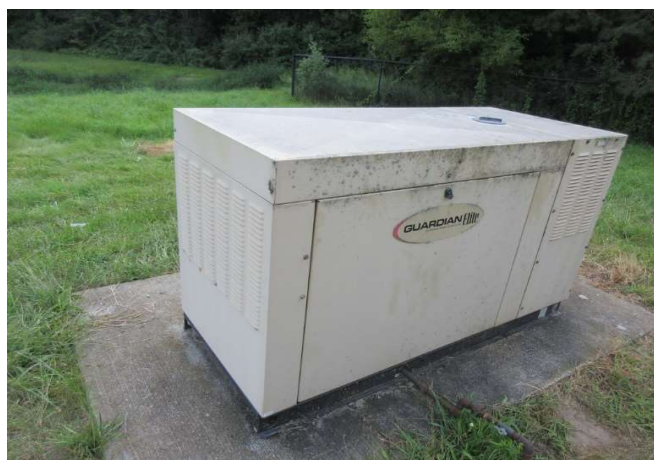
Generator at lift station

Generator at wellhouse

Transfer switch

Generator near pumphouse

There are three natural gas emergency generators located in the community. The generators include a 20-kW, 30-kW, and 100-kW units. The association reports that they have had to do repairs to several of the generators in the recent past. We have included replacement funds in this reserve study for all three generators by 2030. Component includes replacement of the transfer switches.

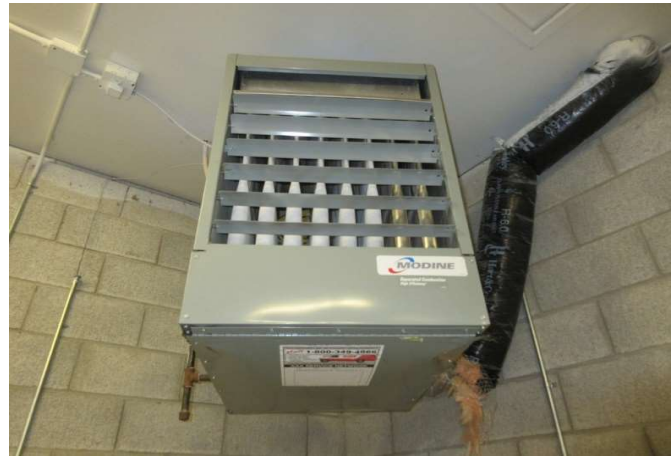
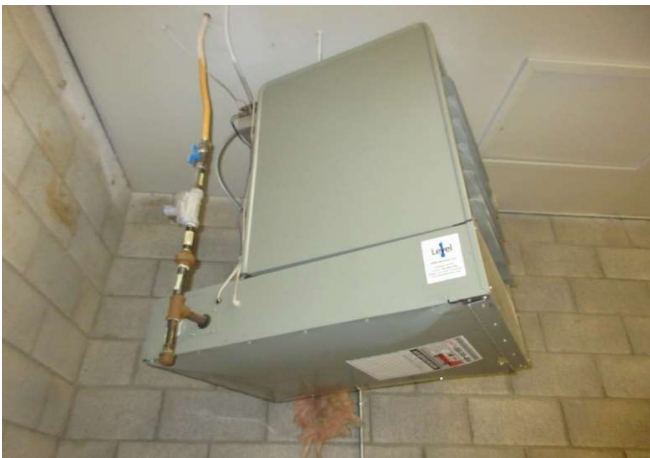
Unit heater

Ceiling mounted heater

View of gas line

Labels at unit

A single gas fired unit heater provides heating for the pumphouse. This unit is a 130 MBH unit. The association reports that the unit was serviced in 2020. We have included replacement of the unit heater by 2030.

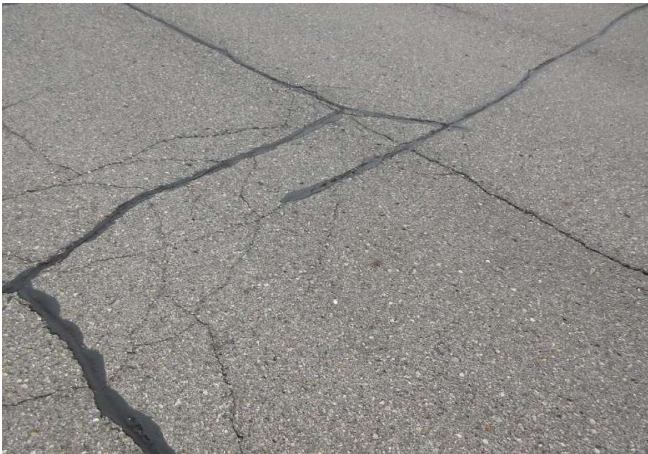
Crackle and repairs

Crack repairs

Engineering Narrative
<p>The association reports that it last completed crack filling and repairs to the asphalt pavement, including the common driveways, paths, and streets, in 2017. The association also indicates that they will not be doing sealcoating in the future. We have included crack repair in patching every five years starting by 2024, with the exception of years of pavement replacement.</p>

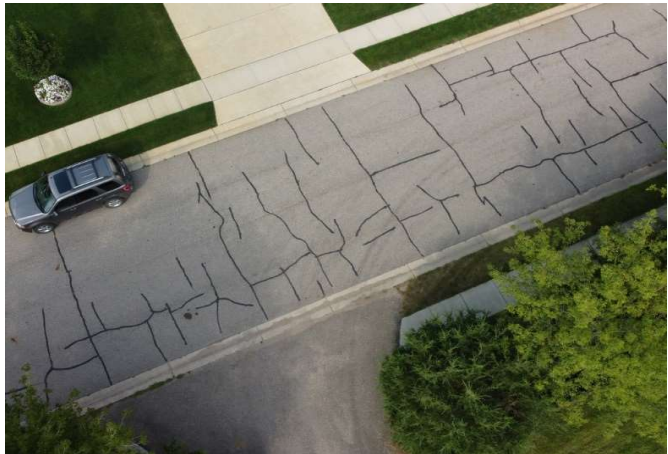
Aerial view showing cracking

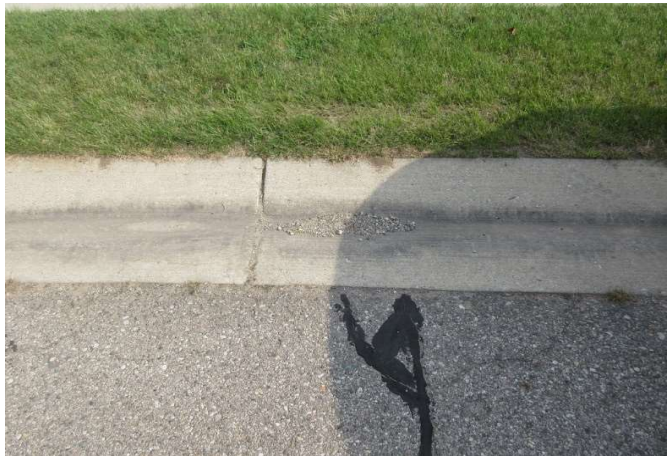
Curb with debris

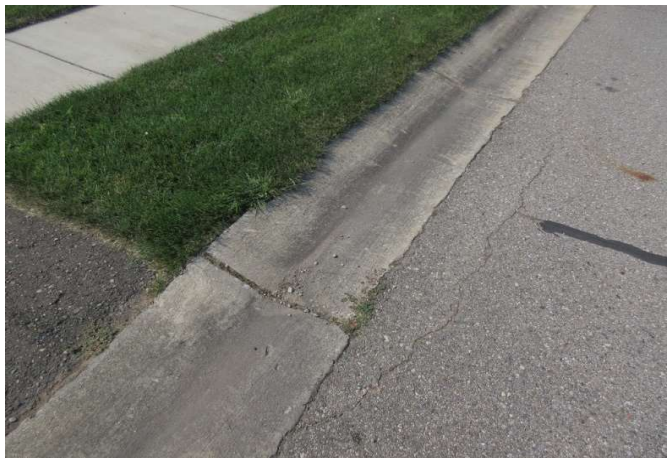
Curb along road

Concrete curbs and gutters line the private streets in the community. These elements are original and largely in good condition, with isolated locations of cracks. Concrete has a long useful life and usually fails in a progressive manner as it approaches the end of its useful life. We include an allowance to replace up to 40% of the curbs and gutters, scheduled in phases coordinated with other paving projects, beginning in 2023.

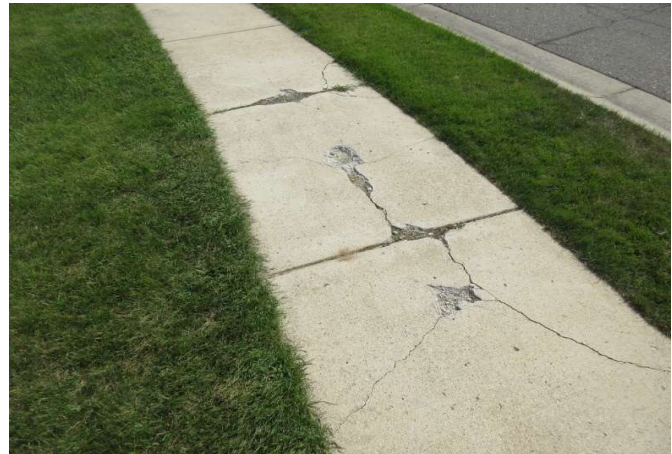
Cracks in walk

The concrete sidewalks are primarily original and in fair condition. Our inspection notes cracks and minor trip hazards. Concrete has a long useful life and generally fails in a progressive manner as it approaches the end of its useful life. Simultaneous failure of the concrete is unlikely. We include an allowance to replace up to 40% of the concrete sidewalks, phased to coordinate with other paving projects.

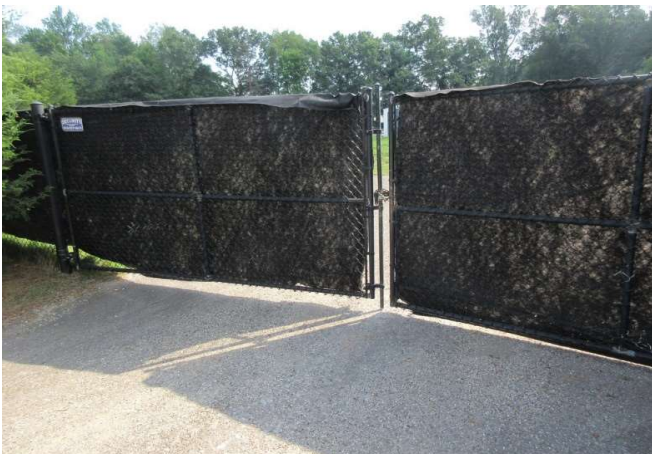
A vinyl coated chain link fence is located near the wastewater treatment facility. This fence is in good condition at an age of 17 years. We have included funds for the replacement of this fencing by 2035.

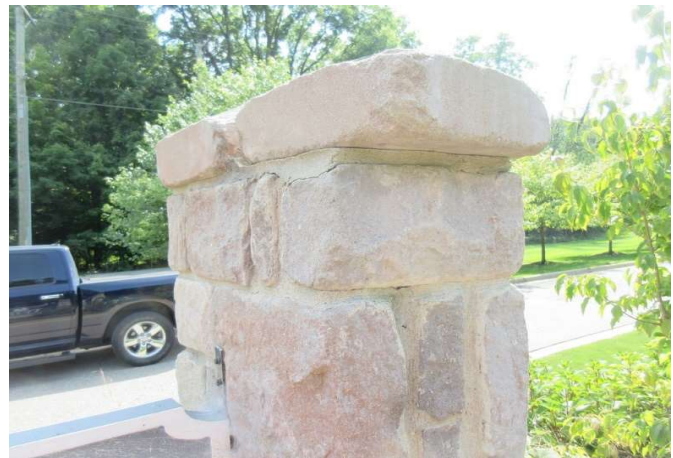
Sign surface

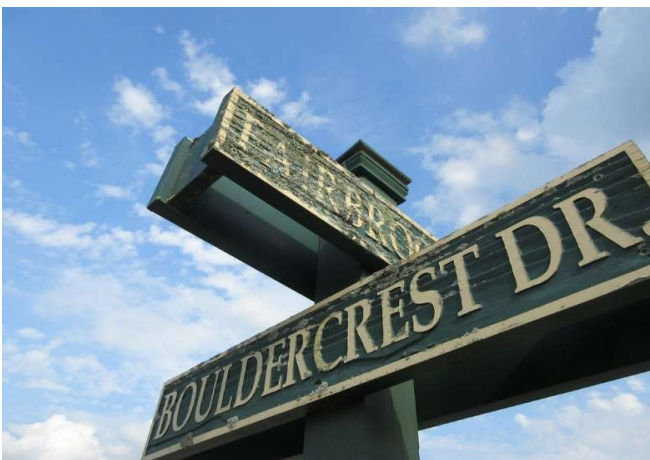
Deteriorating street signage

The board reports that the existing street identification and traffic signage, including 11 street signs, 4 stop signs, 4 yield signs, 4 one way signs, and 8 wood posts, will be replaced in the near future. We have included this replacement by 2023, with subsequent replacement 20 years later.

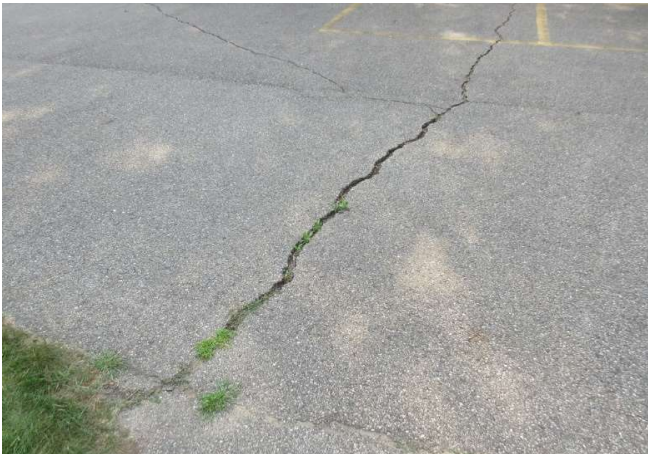
Crack in court

Basketball court surface is in fair to poor condition at an age of 17 years. There are several large cracks running through the pavement. We have included replacement of the asphalt basketball court in 2026, with subsequent replacement by 2046. The 2046 instance corresponds with replacement of the basketball goals.

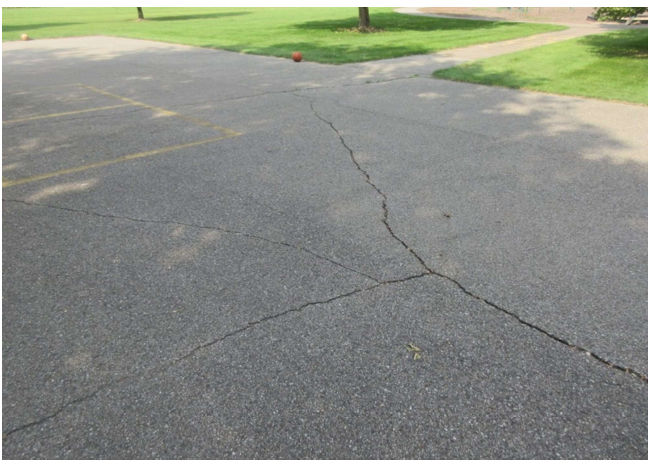
Cracked asphalt basketball court

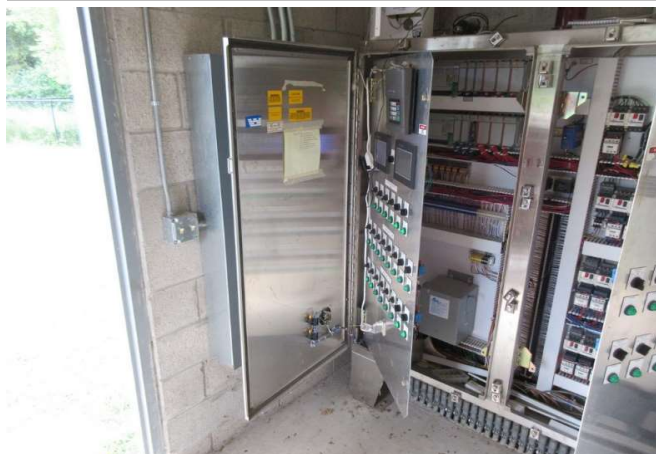
View of alarm panel

Engineering Narrative
<p>There are two alarm dialers serving the wastewater treatment facility. The alarm dialers are reported in good overall condition at an age of three years. Component condition, age, and replacement cost were obtained through discussions with the wastewater treatment operating company. Based on discussion with the operator the replacement of the dialers has been included in 2039.</p>

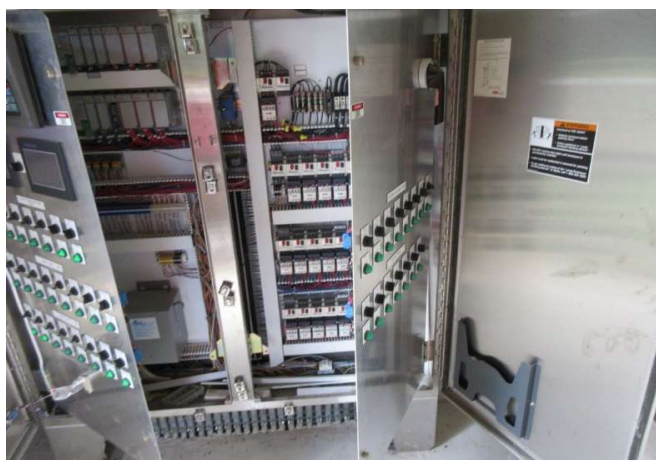
Panel was open during inspection

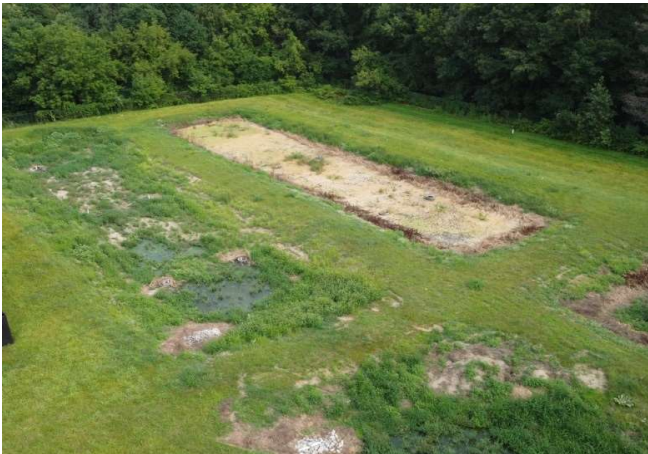
Overview of leach fields

There are four leach fields located at the wastewater treatment facility in the community. The wastewater treatment operator reports that the leach fields will need to be top dressed every 15 years. It is estimated that the leach fields are in fair condition and that the fields will need topdressing by 2028. Component cost was obtained from the wastewater treatment operator

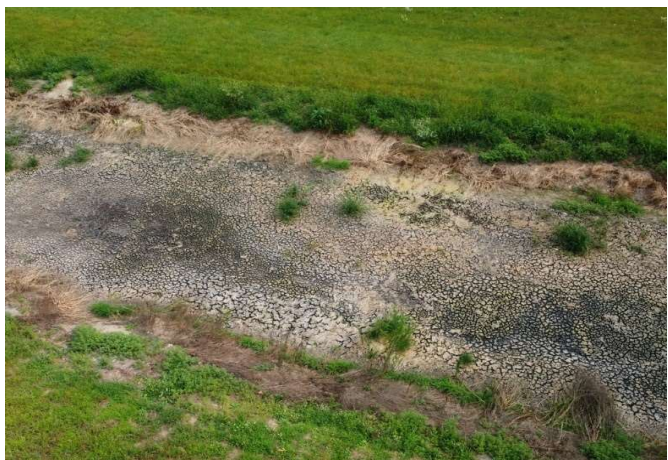
View of leach field

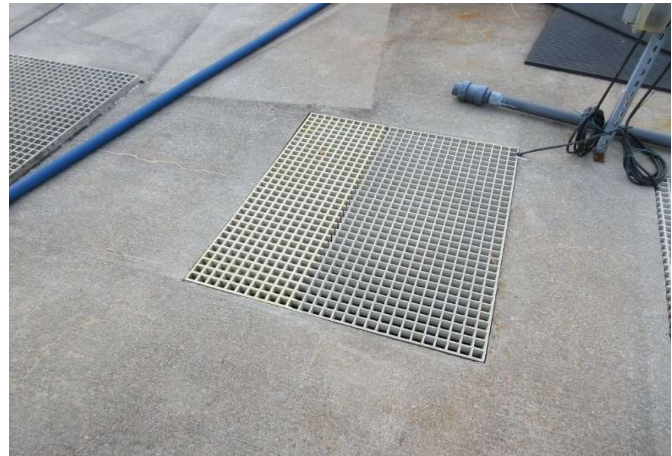
View of access panel

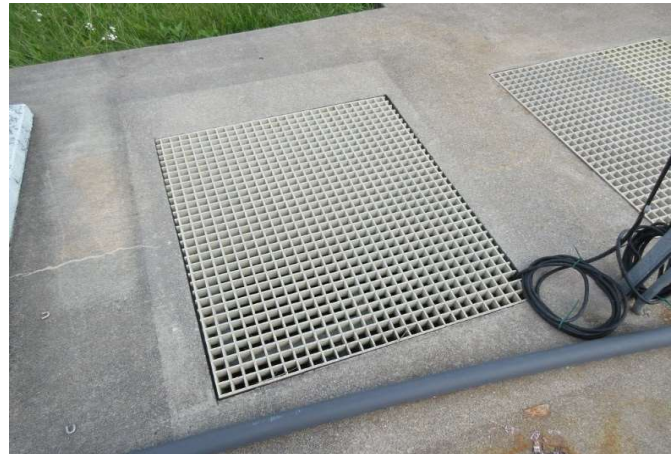
Vented treatment system hatch

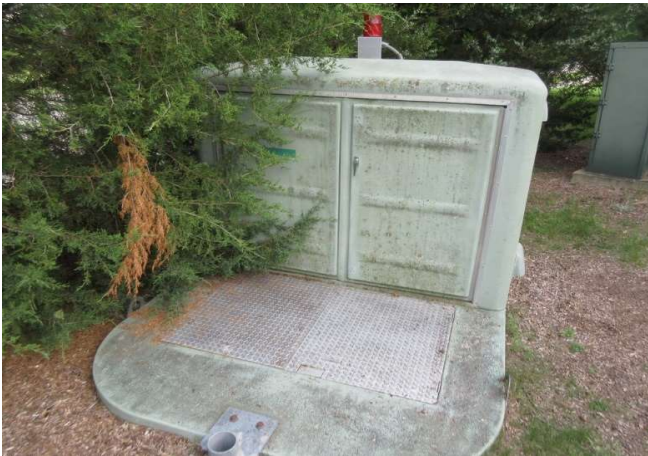
Typical lift station

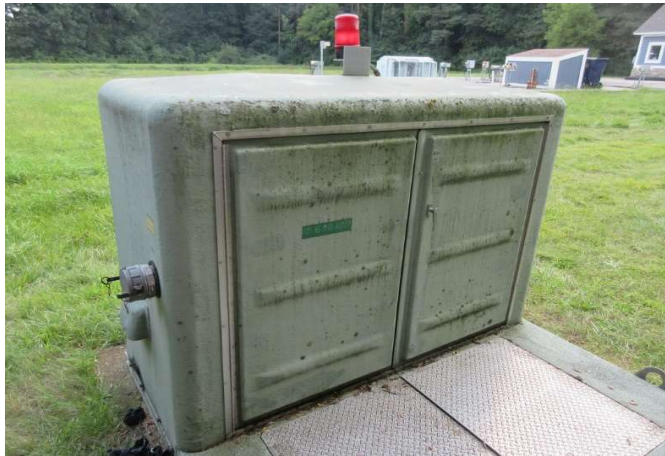
Lift station cover

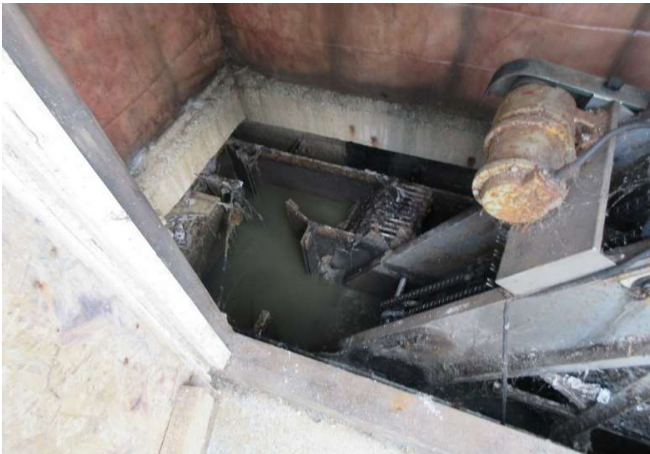
Interior debris screen

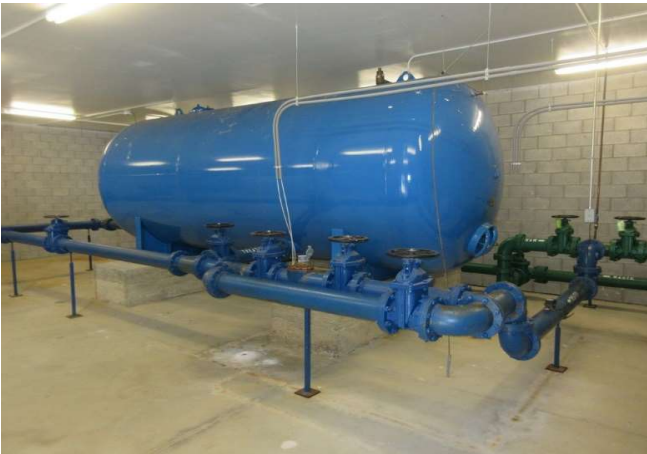
View of tank

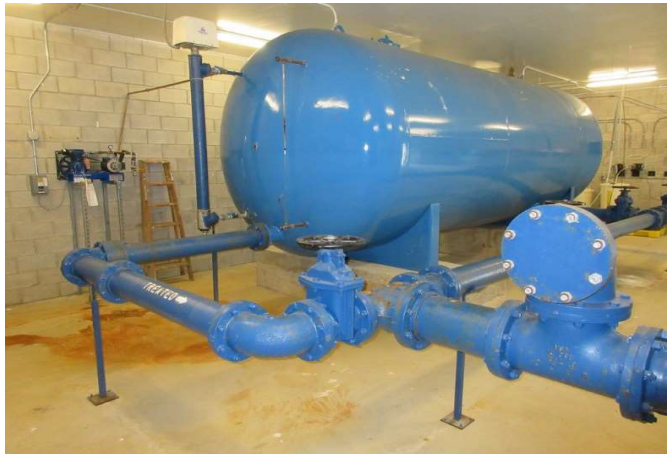
Tank and piping

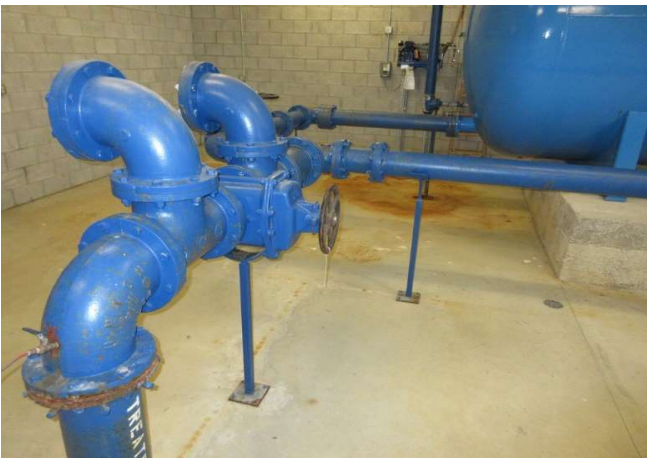
Piping at tank

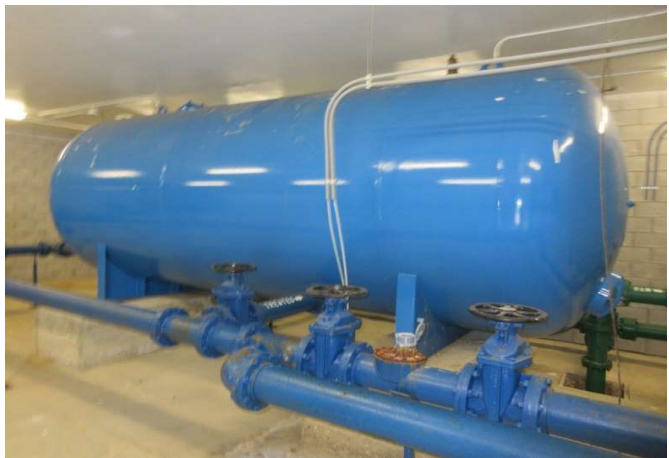
View of water storage tank
