RESERVE STUDY

Stone Ridge Condominium Homeowners Association, Inc.
11450 Ashland Circle
South Lyon, MI

Date of Inspection: August 16, 2021

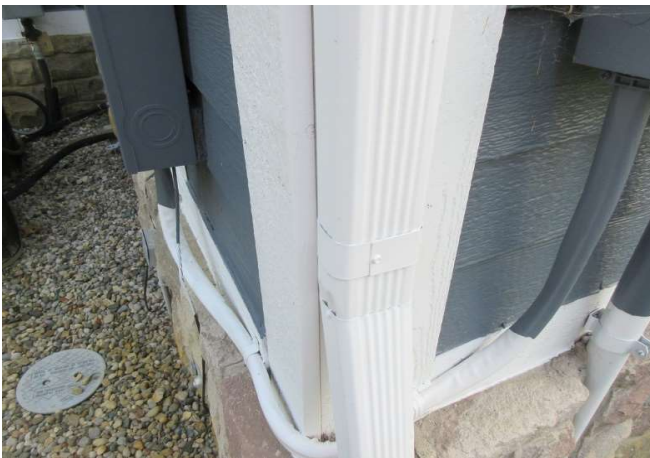
Typical downspout

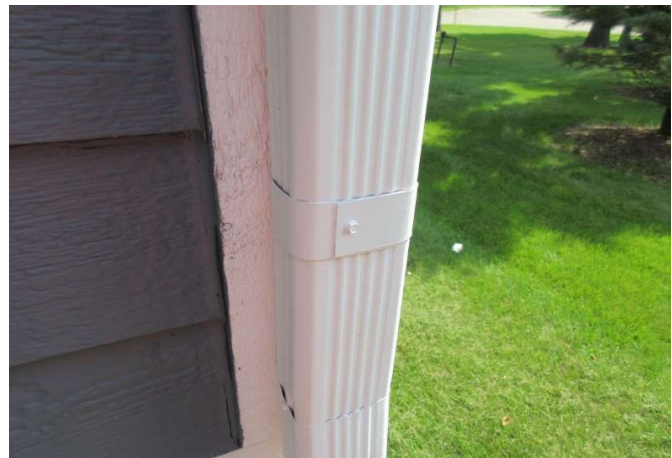
Downspout connection

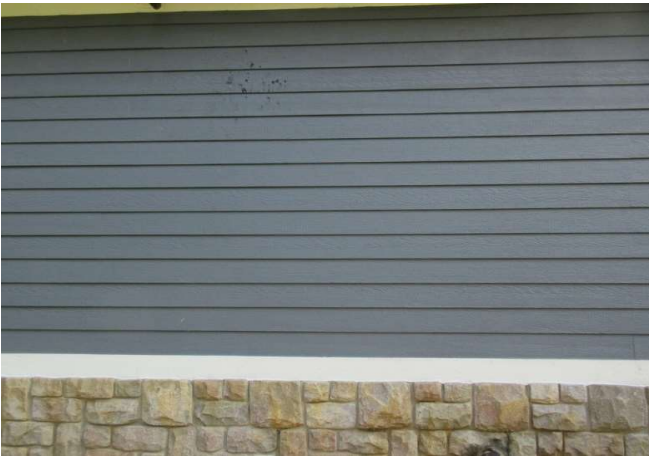
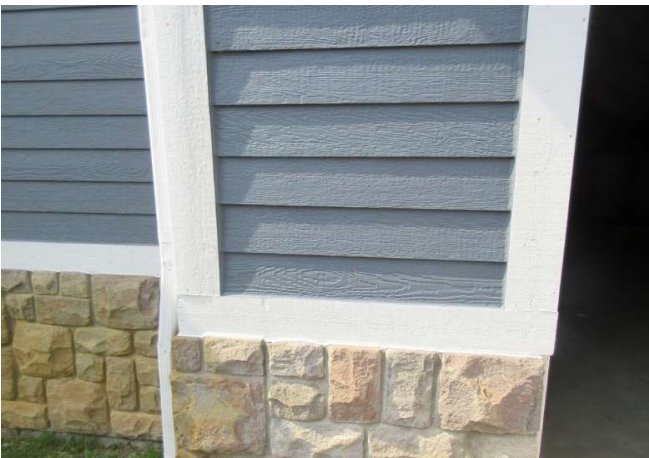
Typical siding

Siding at clubhouse

Siding surface

Detail of siding

The three common buildings (clubhouse, wellhouse, pumphouse) are clad in composite siding. The siding was recently painted (2020) and the condition is good. Composite siding has a typical useful life of 35 to 45 years. We recommend replacement by 2050. Please note that this component also includes the soffits and fascia at the common buildings.

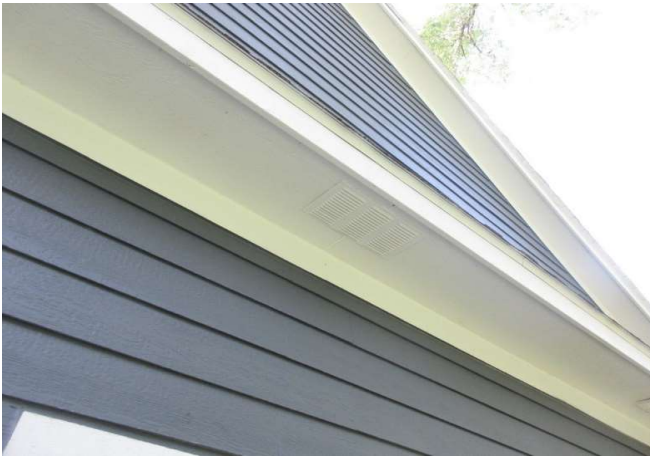
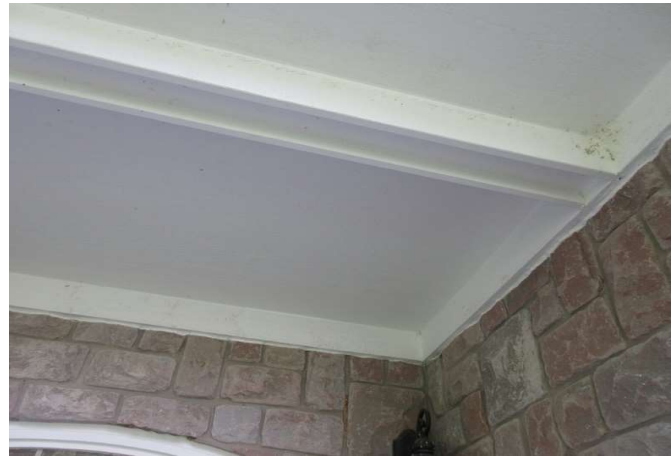
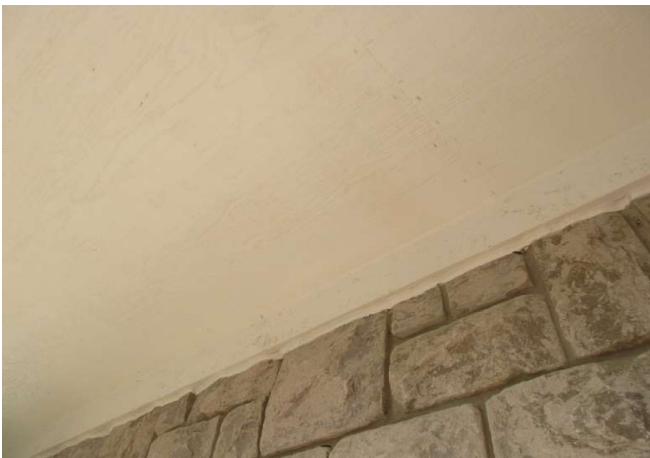
Wood soffit

Painted wood soffit at entry

Painted surface

Vented soffit panel and painted surfaces

The exterior of the clubhouse, wellhouse, and pumphouse are comprised of composite siding with wood soffits and fascia. The exteriors of the common buildings were painted in 2020. We have included future painting and partial replacement of wood fascia and soffit every 6 years starting in 2026. This will allow the upkeep of the building exteriors and replacement of any poor condition areas of wood throughout this study.

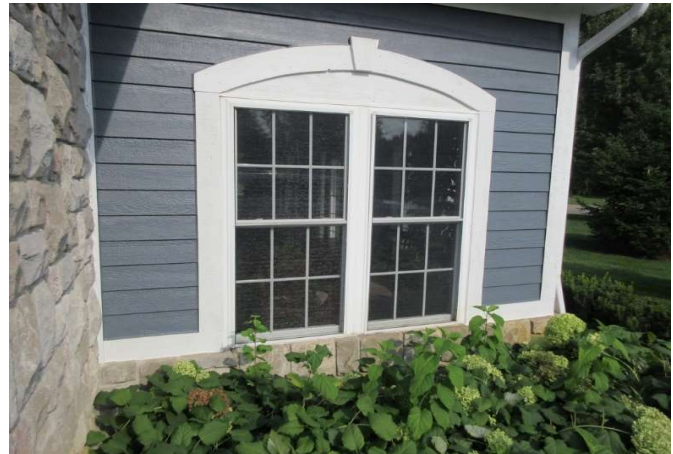
Typical clubhouse entry door

Window, typical

View of bay window

Window at pumphouse

This component includes the replacement of the windows and exterior entry doors at the clubhouse. Utility doors located at the wellhouse and pumphouse are considered an operating cost for replacement. We recommend that the Association reserve funds for replacement of the windows and entry doors by 2050, in coordination with siding replacement.

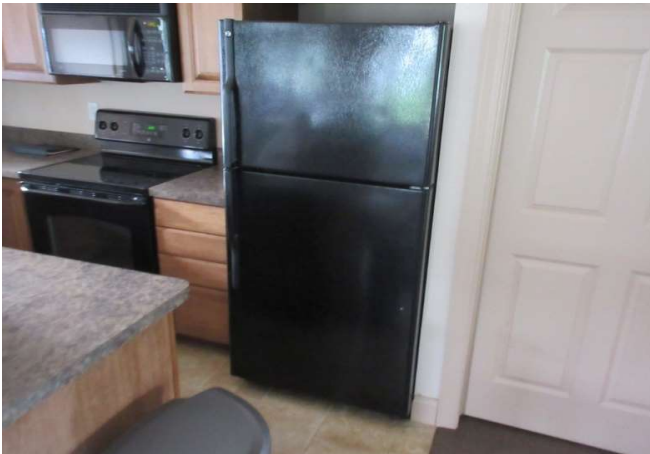
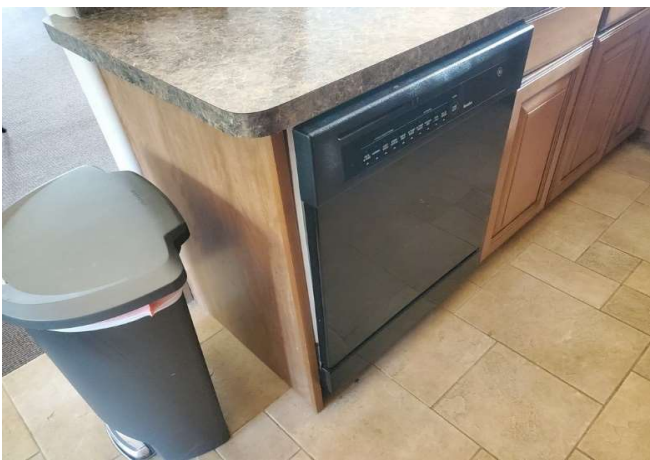
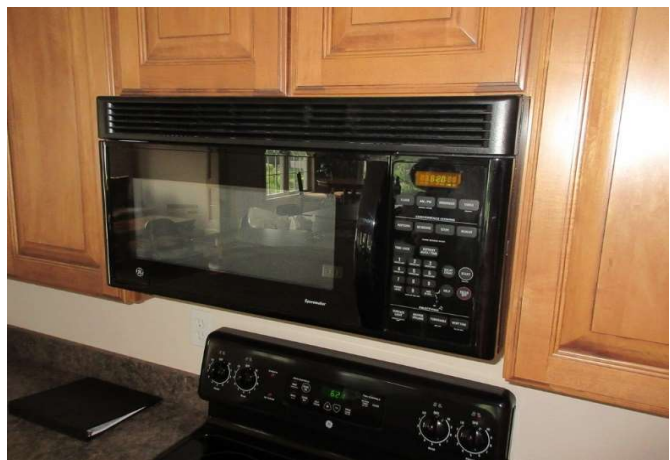
Refrigerator

Oven at kitchenette

View of dishwasher

Microwave above oven

The appliances at the clubhouse include a refrigerator, stove with cooktop, microwave, and dishwasher. These items date from the original construction of the clubhouse. We recommend replacement of the appliances by 2030.

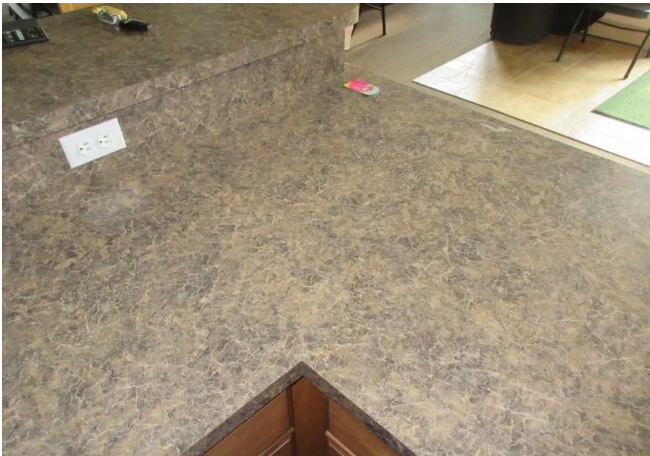
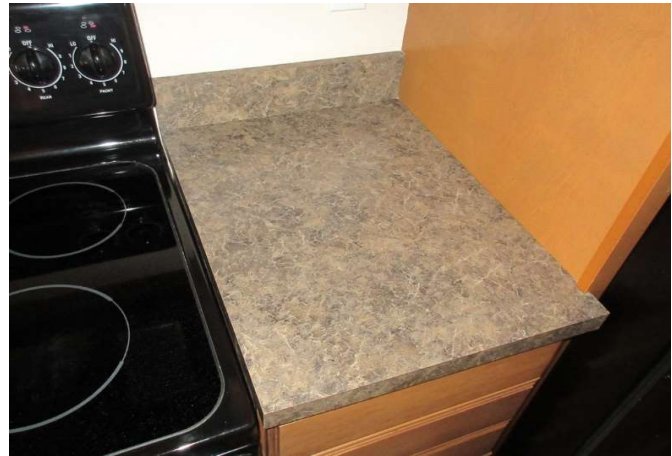
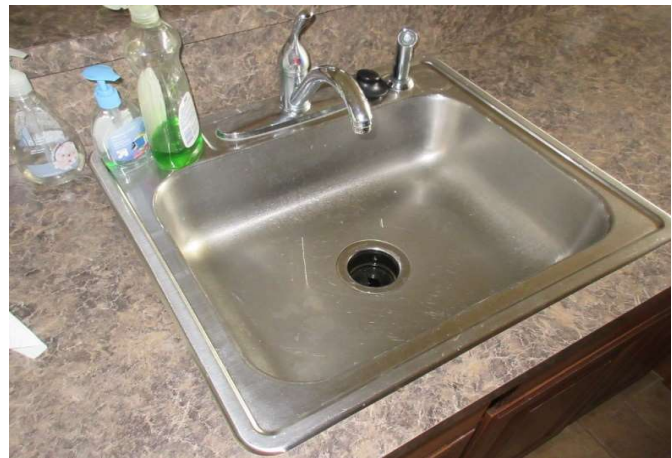
View of countertop

Countertop at oven

Typical cabinets

Sink and cutout

Engineering Narrative
<p>This component includes the floor and wall cabinets, as well as the laminate countertops in the kitchenette area located in the main clubhouse room. The cabinets and countertops are in good overall condition and are 17 years of age. We recommend replacement by 2040.</p>

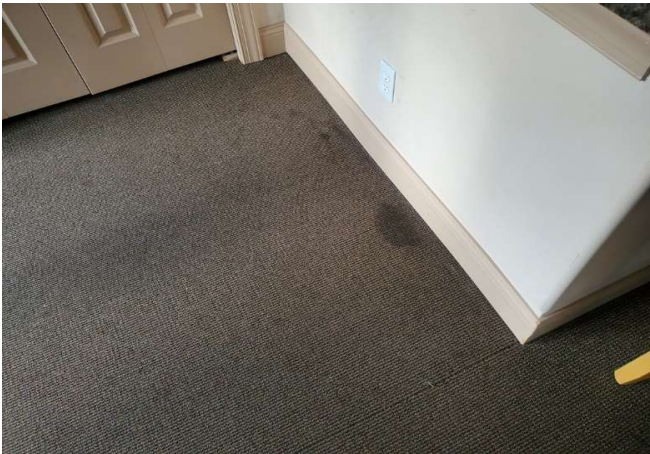
Overall Current Condition:	Poor
Useful Life in South Lyon, MI	8 to 12 Years
Full or Partial Replacement:	Full

Stained carpet

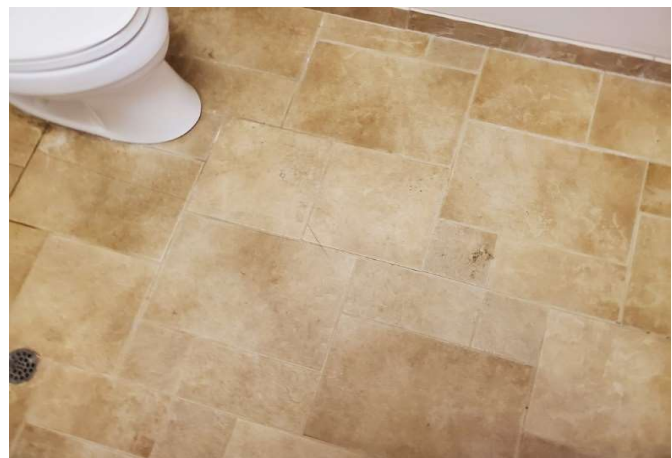
Tile in hallway

Restroom tile

Floor in clubhouse hallway

Typical condition

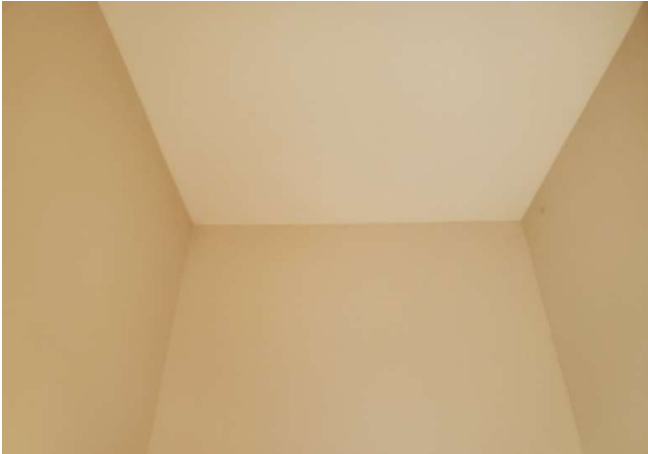
Painted ceilings in hallway

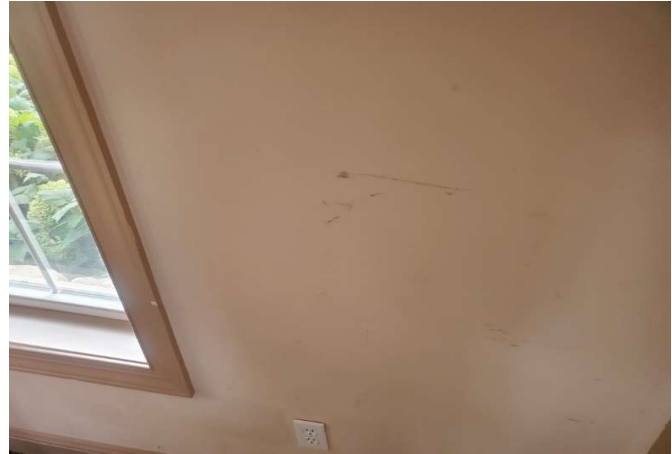
Scuffs on paint

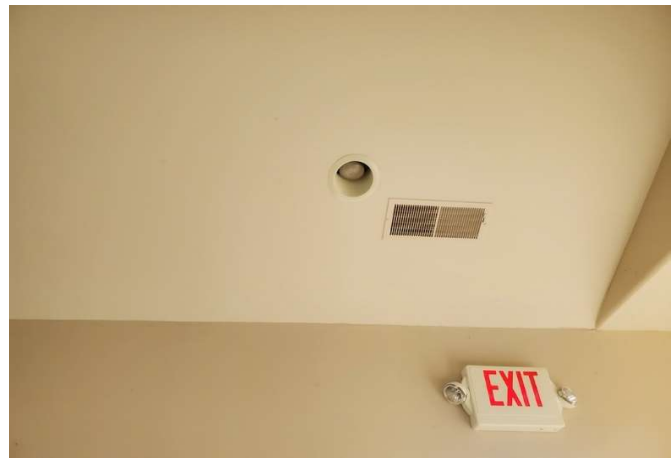
Paint in clubhouse

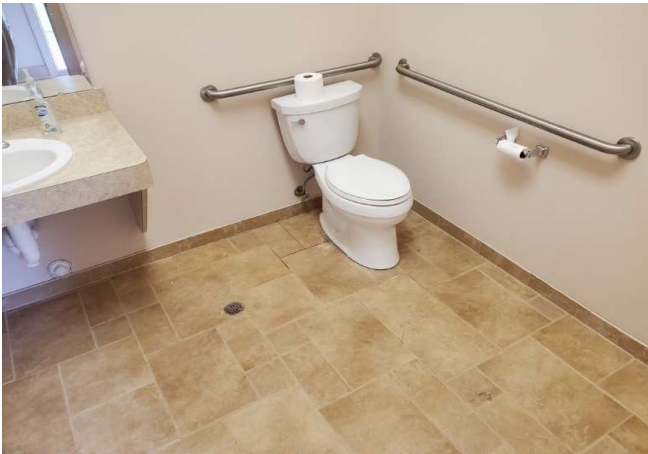
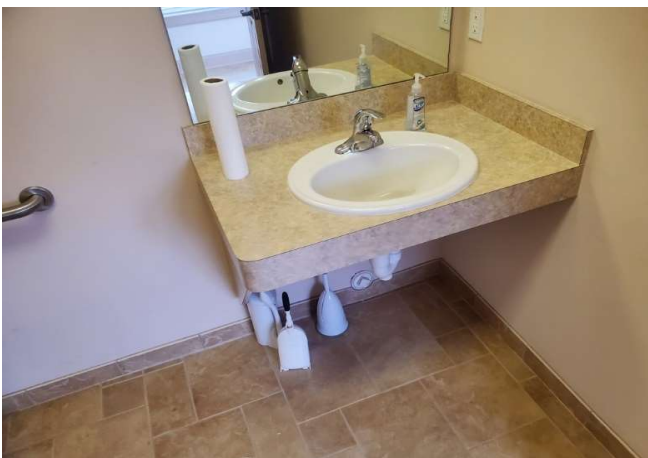
Restroom toilet area

Sink area, typical

Sink countertop

ADA accessible toilet area

Engineering Narrative
<p>Two rest rooms are located in the clubhouse. The finishes of the rest rooms include ceramic tile and paint, which have been included in separate components in this report. Renovations to the restrooms include replacement of fixtures including toilets, sinks, and accessories. The timing and cost of rest room renovation can vary significantly depending on the desires of the Board. At this time, we include an allowance to renovate the rest rooms by 2040.</p>

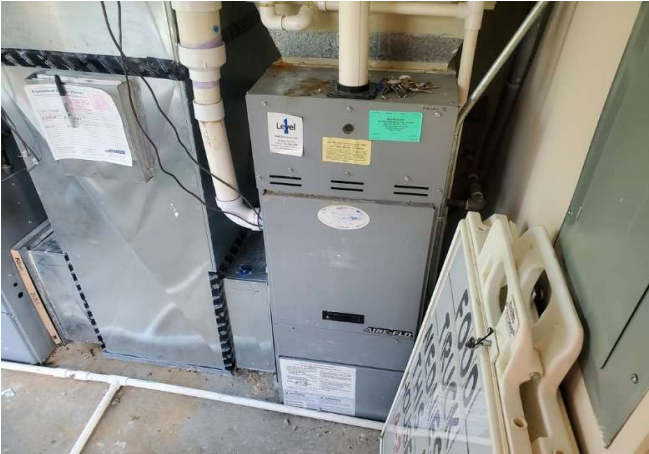
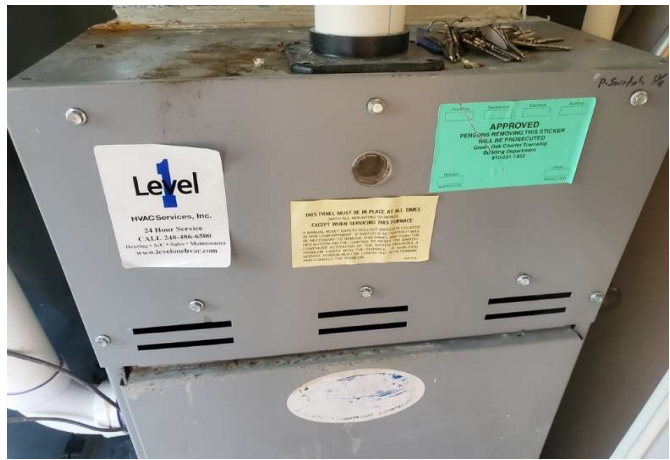
Typical AHU

AHU in mechanical room

View of furnace

Furnace

There are 2 air handling units located in the mechanical room at the clubhouse. These units appear in fair condition at an age of 17 years. We recommend that the association reserve funds for replacement by 2025, and again by 2045, in conjunction with replacement of the condensing units. The units are 100-MBH gas fired units.

Overall Current Condition:	Fair
Useful Life in South Lyon, MI	15 to 20 Years
Full or Partial Replacement:	Full

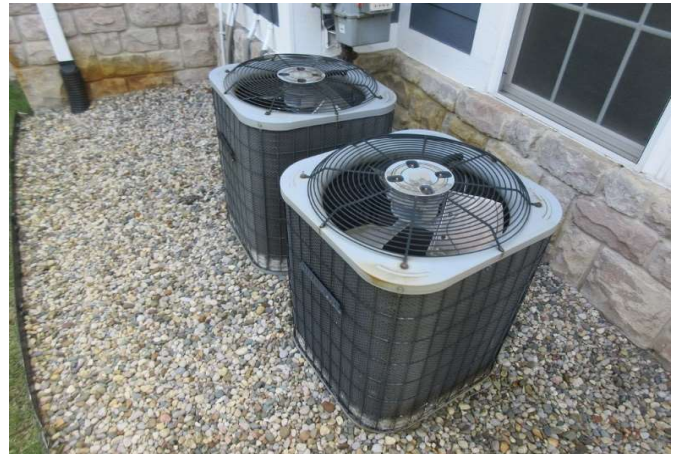
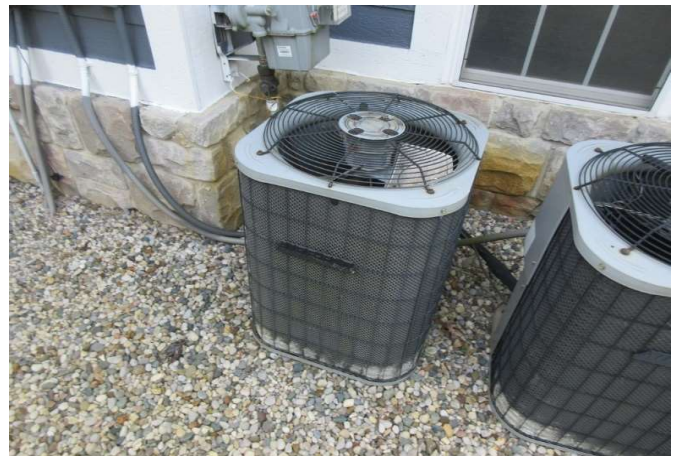
Condensing units at clubhouse

Typical condition

View of condensing unit

Typical unit

Two condensing units are located at the clubhouse. These condensing units date to the original construction of the clubhouse. Condition of these units appears fair. We recommend that the association replace the condensing units at the clubhouse at the same time as furnaces in 2025, and subsequently in 2045.

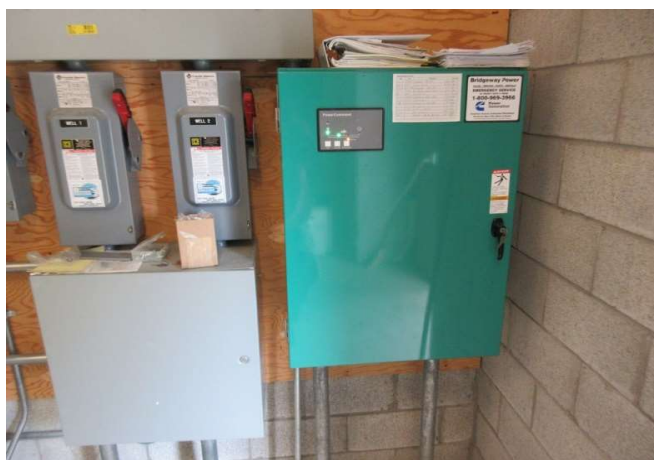
Generator at lift station

Generator at wellhouse

Transfer switch

Generator near pumphouse

There are three natural gas emergency generators located in the community. The generators include a 20-kW, 30-kW, and 100-kW units. The association reports that they have had to do repairs to several of the generators in the recent past. We have included replacement funds in this reserve study for all three generators by 2030. Component includes replacement of the transfer switches.

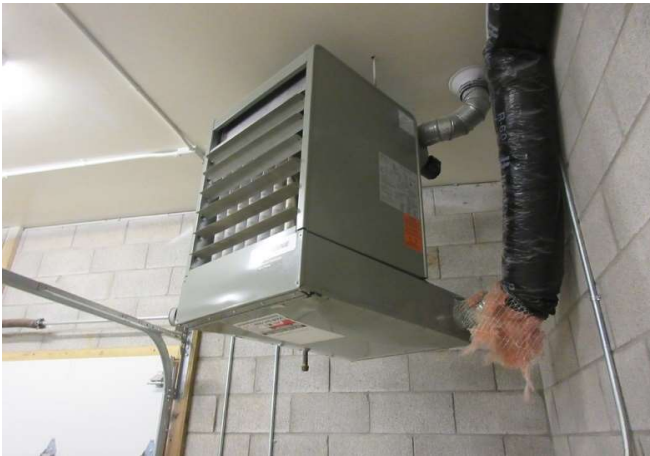
Unit heater

Ceiling mounted heater

View of gas line

Labels at unit

A single gas fired unit heater provides heating for the pumphouse. This unit is a 130 MBH unit. The association reports that the unit was serviced in 2020. We have included replacement of the unit heater by 2030.

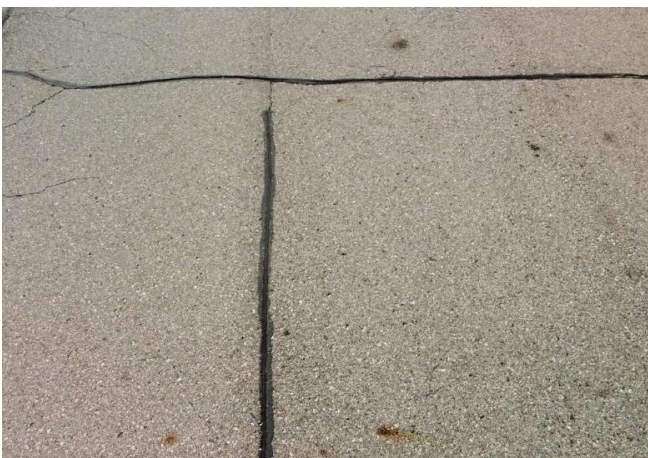
Crackle and repairs

Crack repairs

Engineering Narrative
<p>The association reports that it last completed crack filling and repairs to the asphalt pavement, including the common driveways, paths, and streets, in 2017. The association also indicates that they will not be doing sealcoating in the future. We have included crack repair in patching every five years starting by 2024, with the exception of years of pavement replacement.</p>

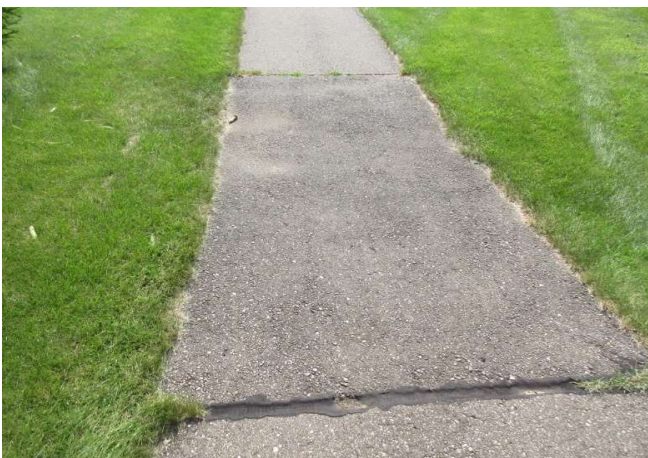
Patched walk section

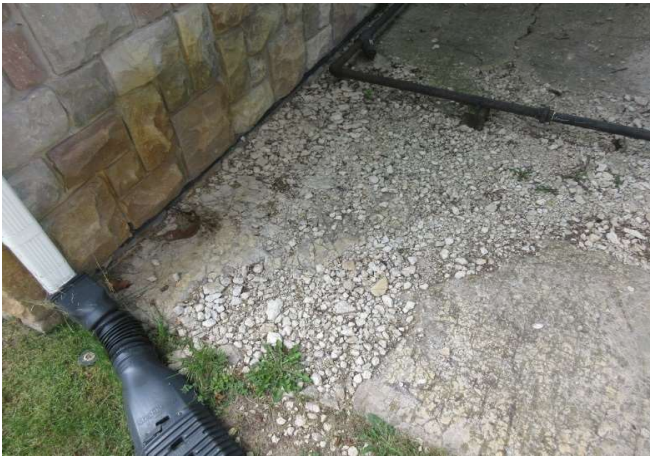
Deteriorated pad

The generator located at the clubhouse is supported by a concrete pad. This pad is deteriorating and in poor condition. We have included replacement of this concrete generator pad in 2023. Cost for this component includes material and construction of the generator pad, as well as rental of a crane to lift the generator.

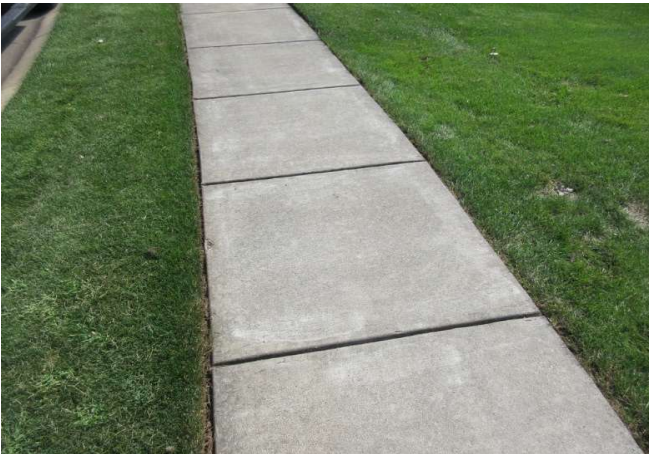
Typical walk

The concrete sidewalks are primarily original and in fair condition. Our inspection notes cracks and minor trip hazards. Concrete has a long useful life and generally fails in a progressive manner as it approaches the end of its useful life. Simultaneous failure of the concrete is unlikely. We include an allowance to replace up to 40% of the concrete sidewalks, phased to coordinate with other paving projects.

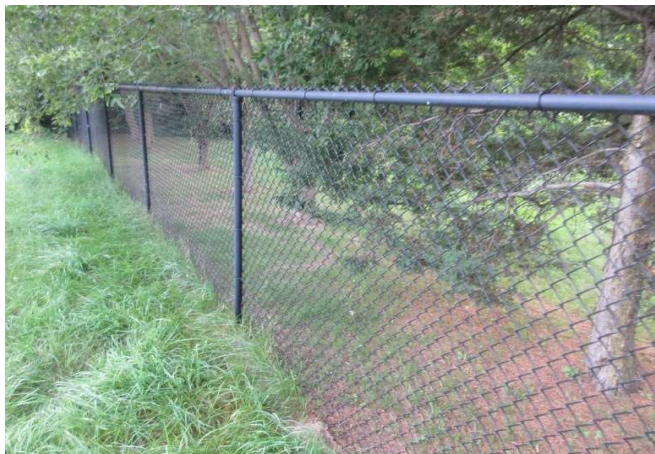
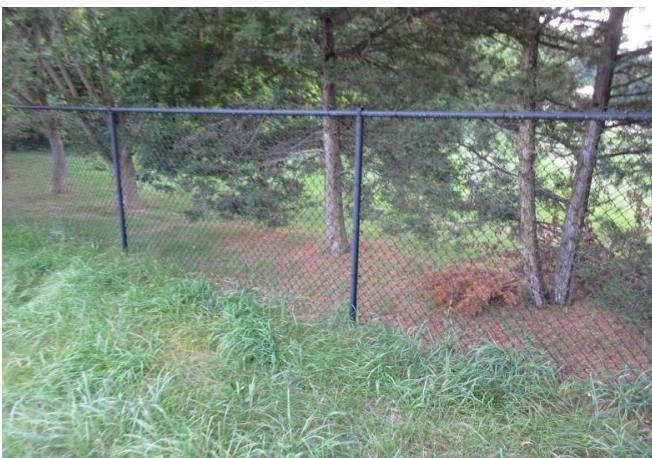
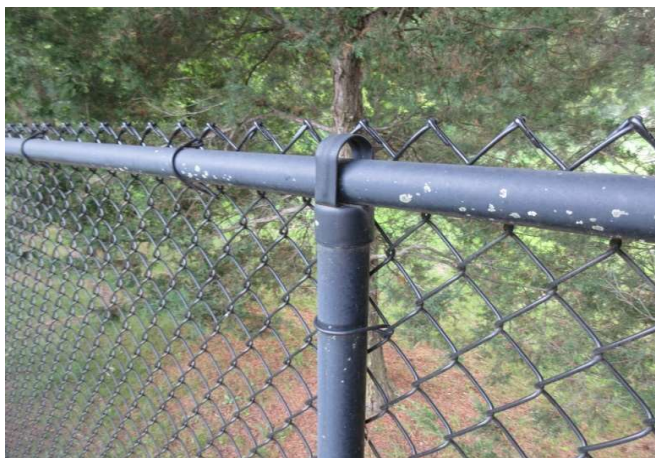
A vinyl coated chain link fence is located near the wastewater treatment facility. This fence is in good condition at an age of 17 years. We have included funds for the replacement of this fencing by 2035.

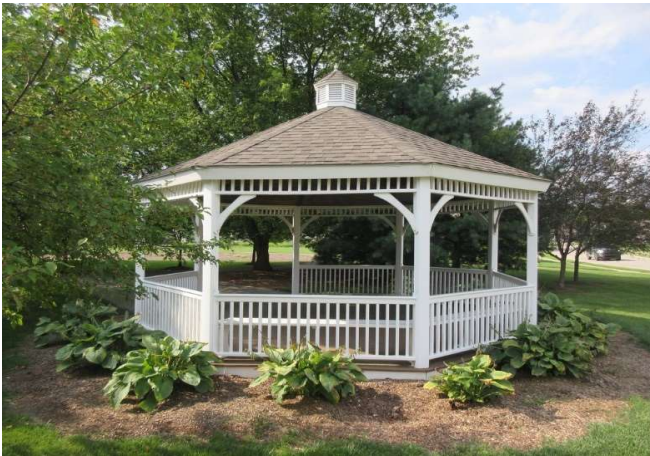
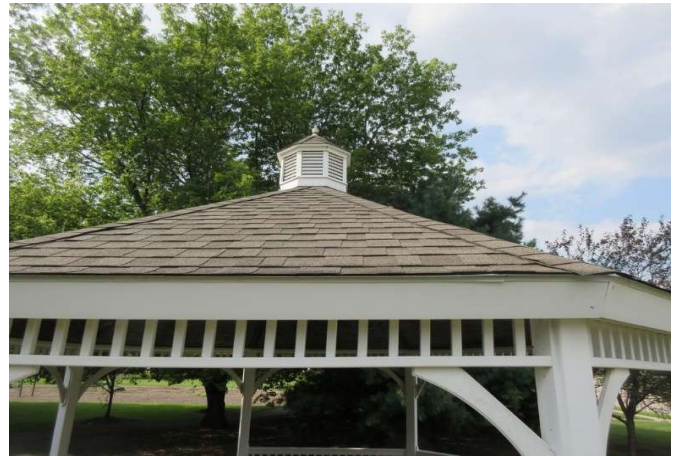
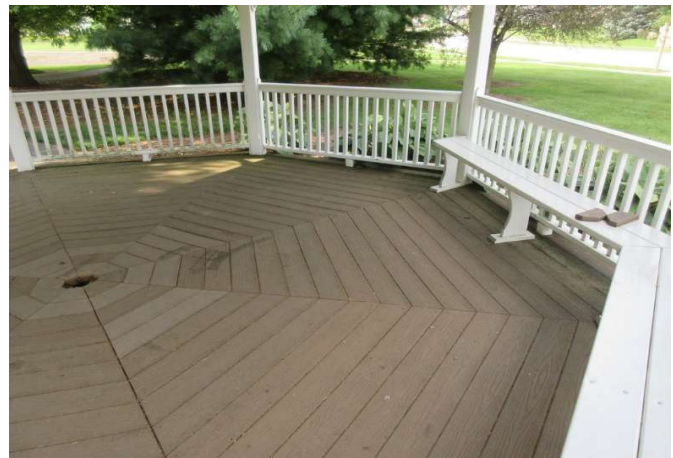
There is a single gazebo structure located in the community. This structure includes architectural dimensional shingle roof, composite decking, vinyl railings, and a wood support structure. Condition of this component is good. The association has been completing repairs as needed out of the operating budget. We recommend that the association reserve funds for the replacement of the gazebo by 2040.

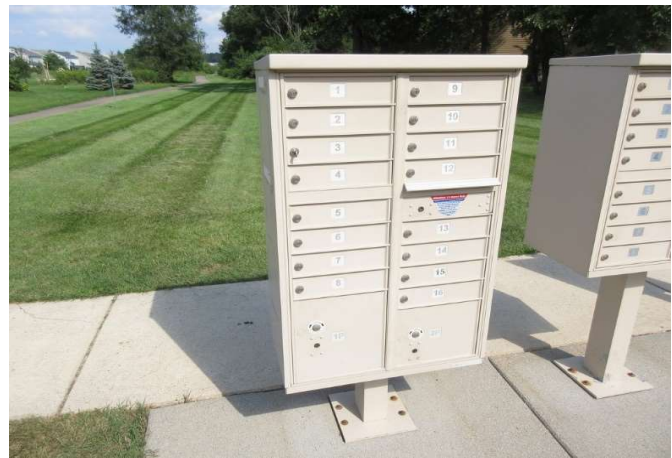
Mailbox in good condition

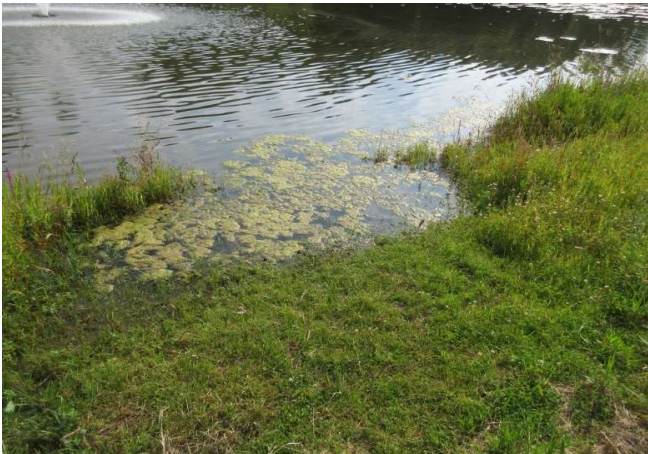
Algae growth

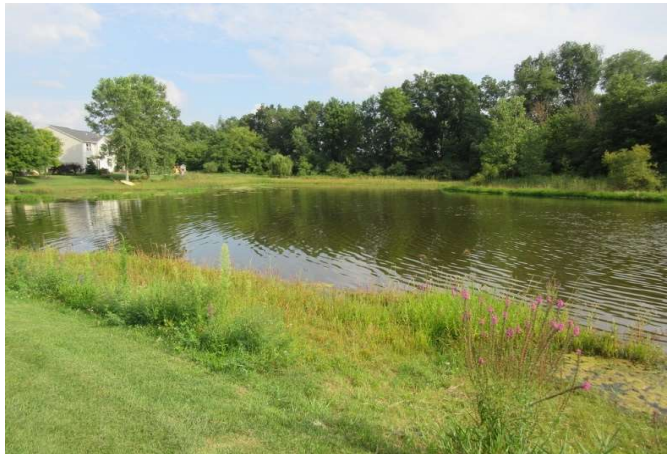
Overgrown shorelines

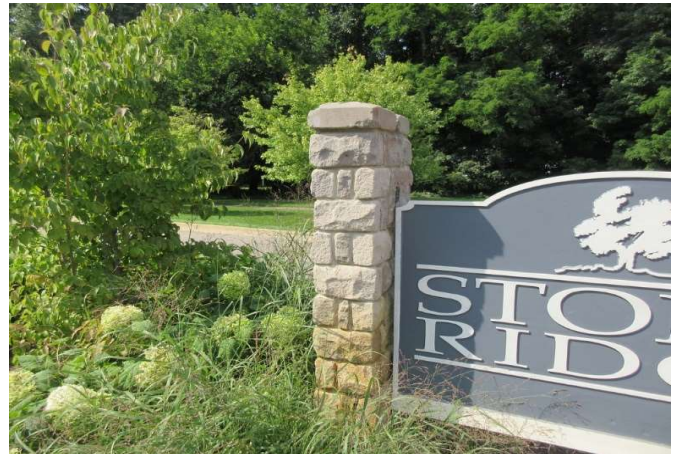
Overview of sign

The association reports that the sign was vandalized recently and repaired. The association is acquiring quotes for replacement of the monument sign. When quotes are obtained for the replacement of the existing composite and masonry sign this report should be updated to reflect those costs.

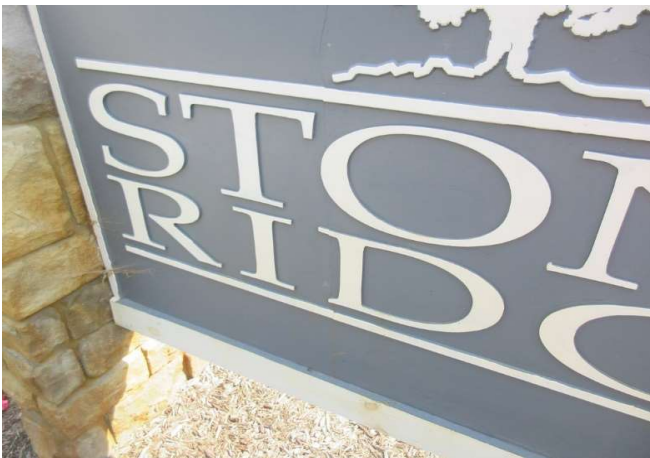
Masonry column

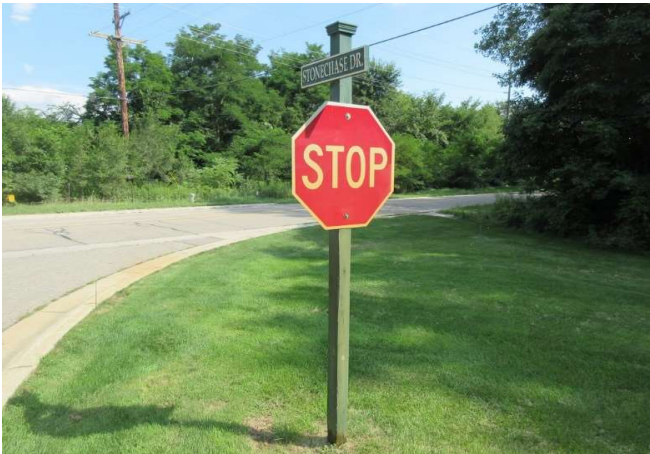
Typical signs

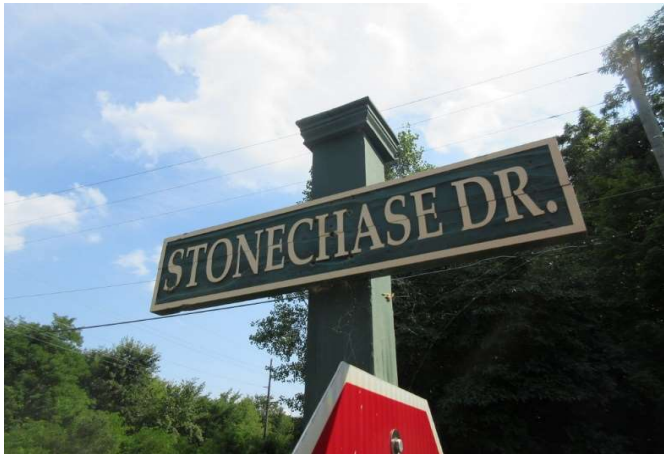
Street sign

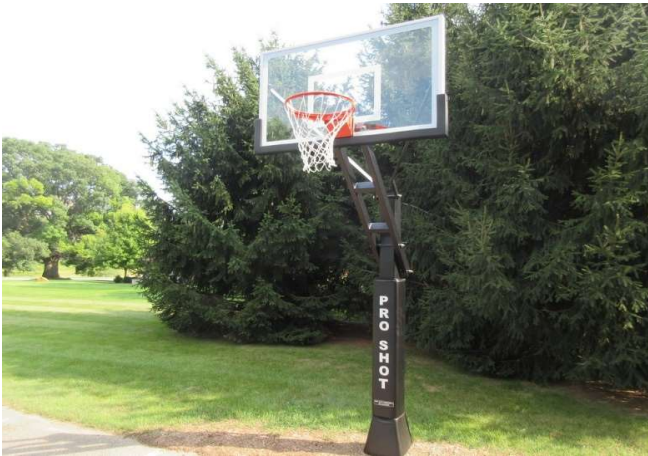
New goal

New basketball goals were installed at the court in 2021. We anticipate that these basketball goals have a useful life of up to 25 years. We have included replacement funds for the basketball goals by 2046. Unit cost is based on the reported cost spent by the association in 2021.

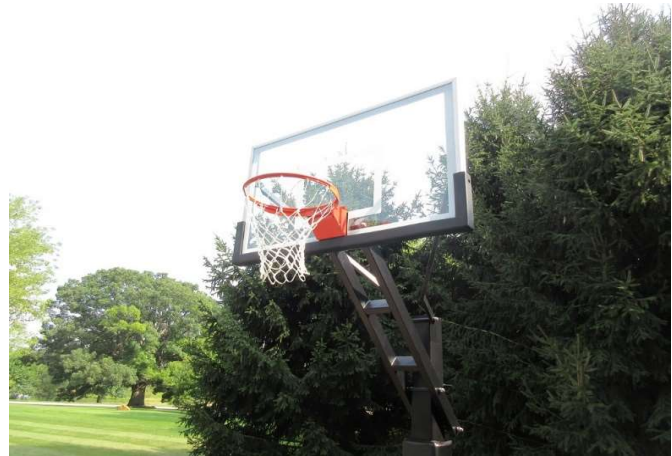
View of backboard

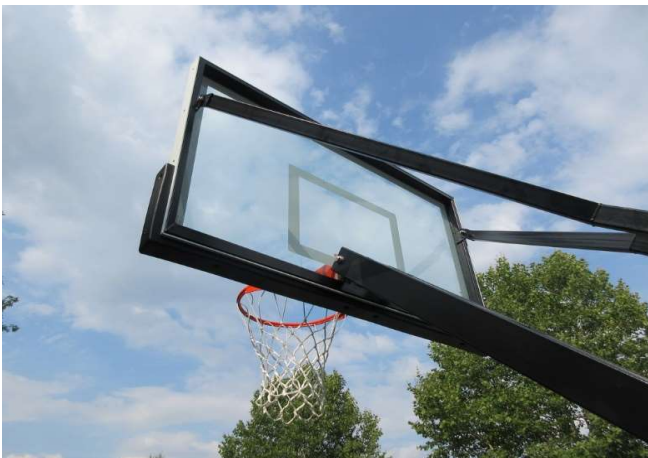
Backboard and hoop

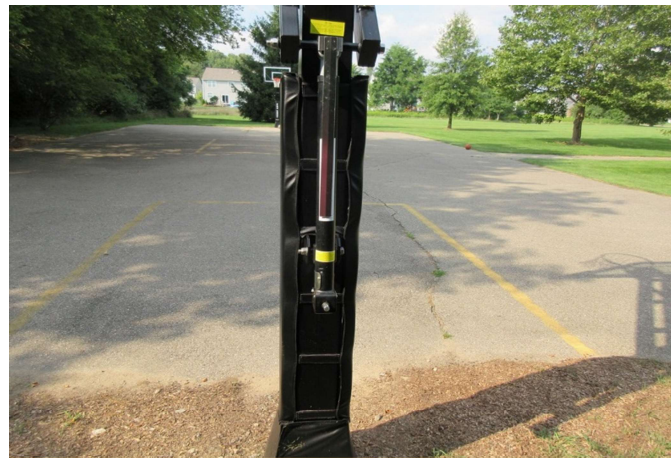
Height adjustment

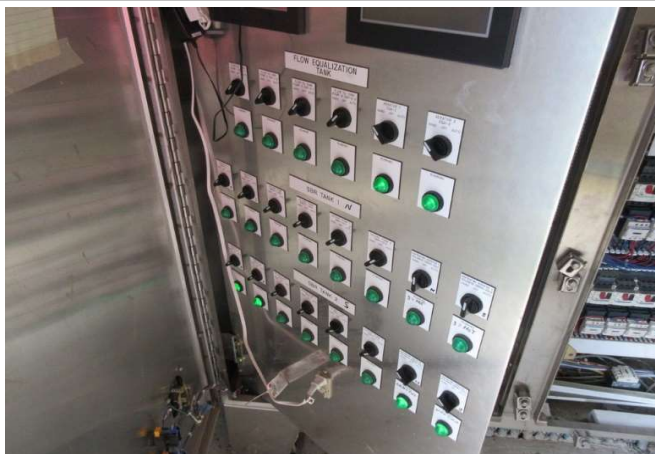
Alarms

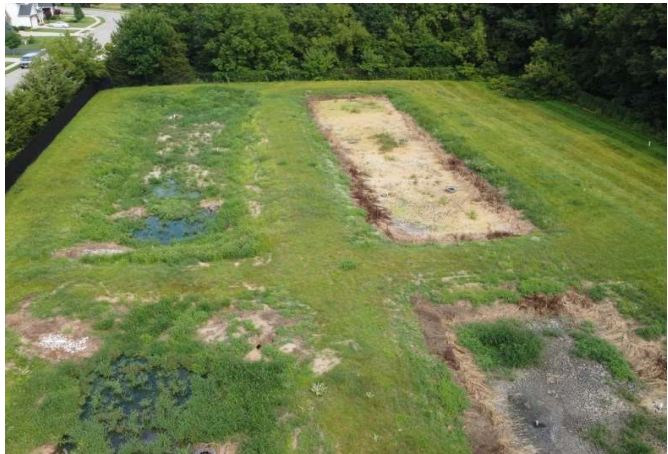
Aerial view

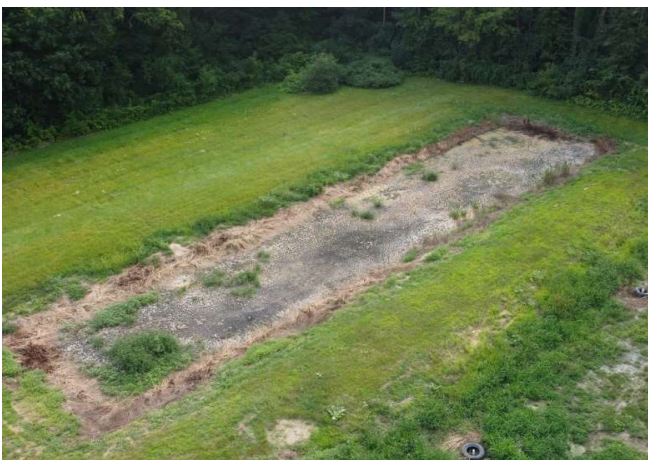
Typical condition

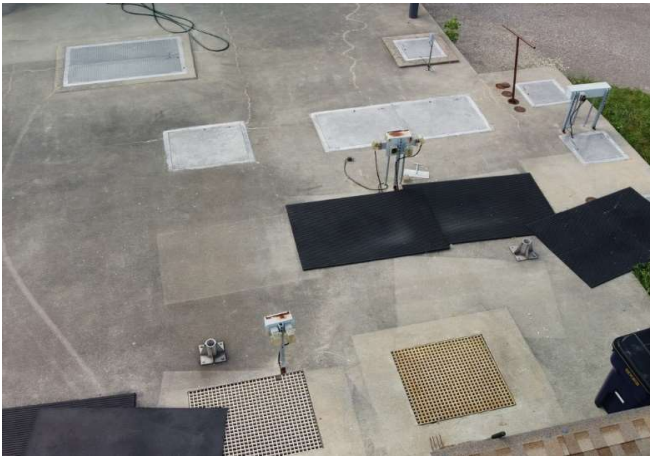
Overview of wastewater system

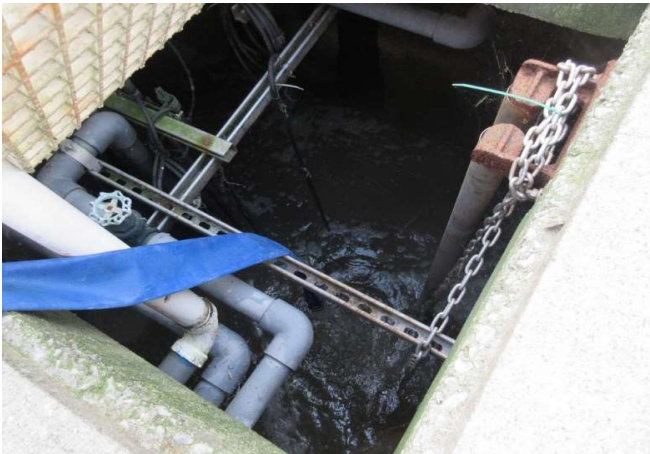
Chamber interior

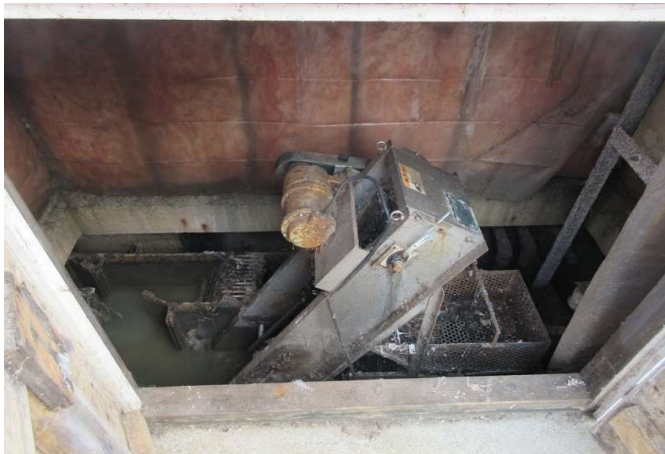
View of interior of station

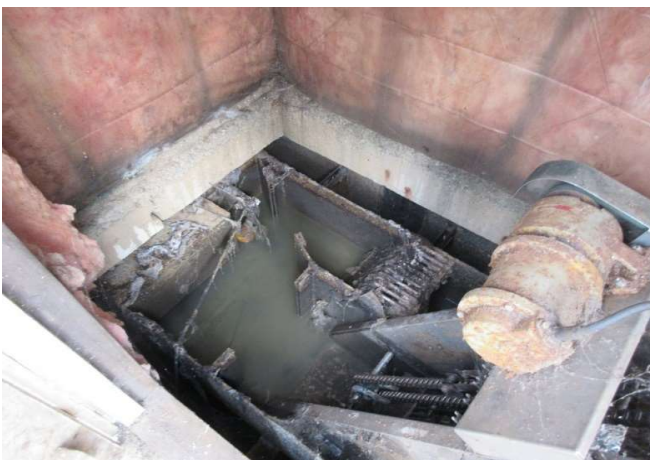
Debris screen

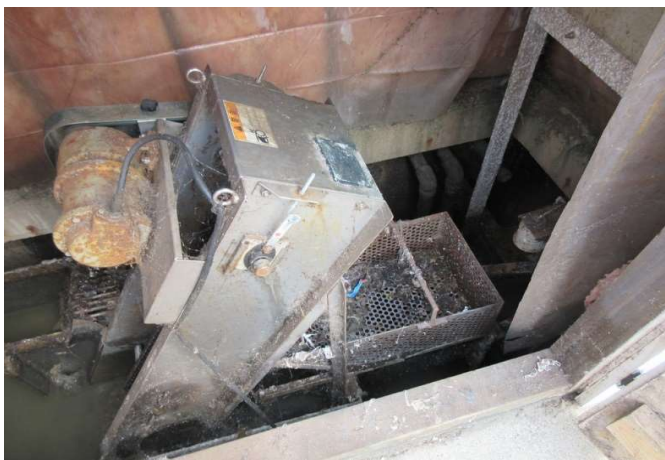
View of screen
